Lower Gordon River erosion monitoring 2018

Update report for the period February 2018 to December 2018

March 2019
Jason Bradbury
Geoconservation Section
Natural Values Conservation Branch
Natural & Cultural Heritage Division
Department of Primary Industries, Parks, Water and Environment

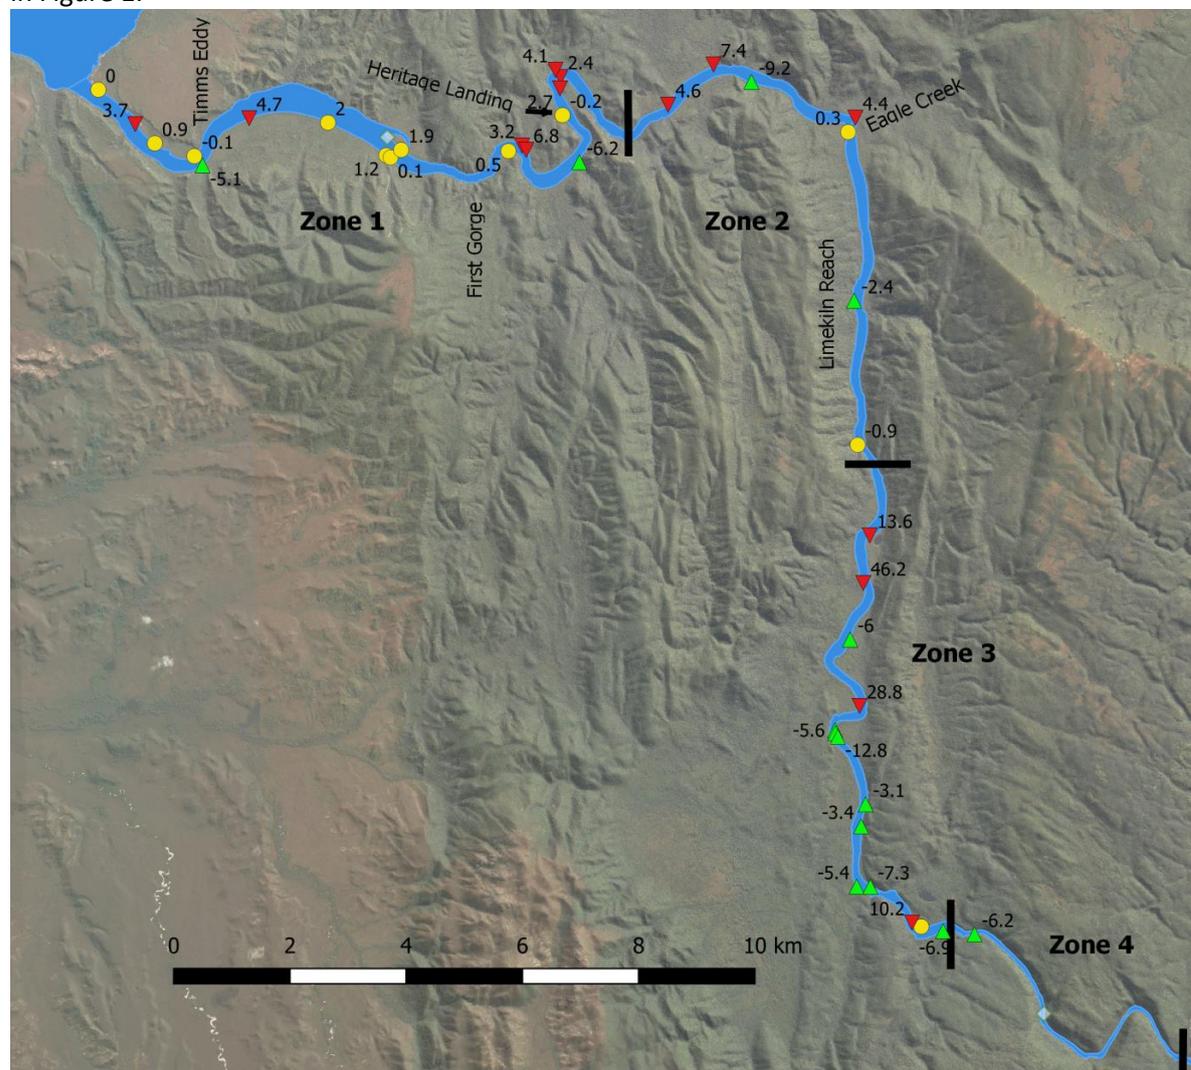
Figure 1: Map of the lower Gordon River area showing the mean rate of erosion of critical landforms (estuarine and alluvial scarps and lower levees) as recorded by multiple pins at each of 40 monitoring sites. Key: red inverted triangles = erosion, yellow circle = no change in average pin exposure exceeding measurement resolution (conservatively +/- 2 mm), green triangle = deposition, grey diamond = not measured. Numbers indicate the average rate of change at each site in mm/yr, zone boundaries are shown as thick black lines.

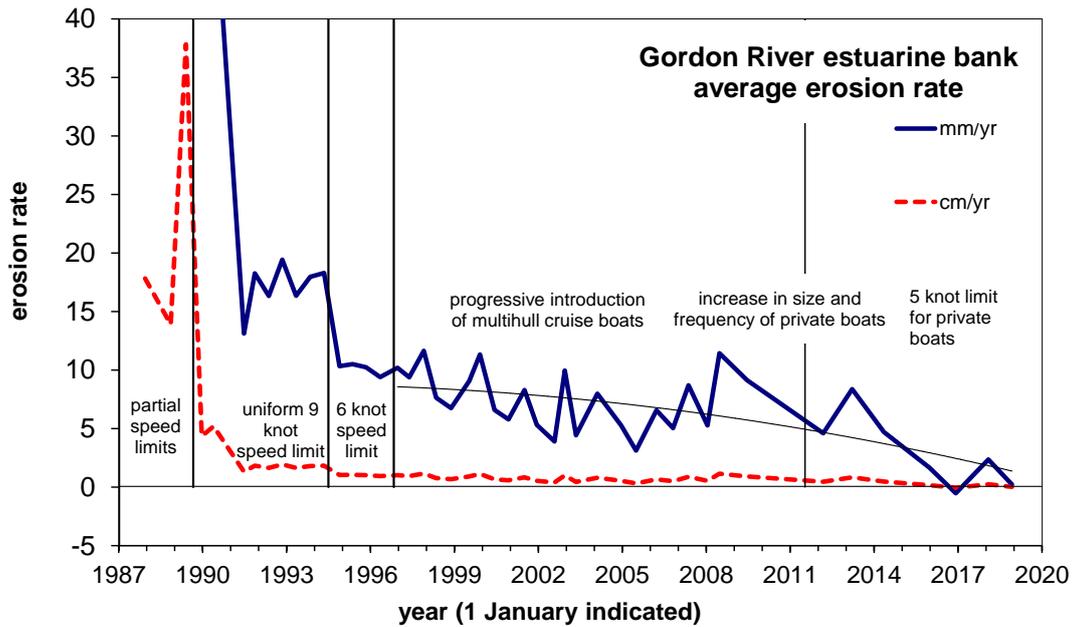
Estuarine bank erosion rates are summarised in Table 1 and Figure 3. Sustained high water level during the monitoring period meant that some 35% of pins could not be located, or if located could not be measured with sufficient accuracy. This is not unprecedented and simply means that some caution is required when interpreting the results. In particular the most recent downturn in the erosion rate should not be considered significant by itself. However, turbidity monitoring data (section 3.4) is somewhat supportive of a decline in erosion rate over the most recent monitoring period. Those pins that could not be measured will, upon next measurement, record the cumulative erosion over two monitoring periods.

Figure 3: Mean rate of estuarine bank erosion (combined scarp and flat) through time. The fine smoothed line shows the best fit trend of the data since the first introduction of multi-hulled cruise vessels.

The previously depositional estuarine banks recorded near zero erosion over the 2018 monitoring period while formerly stable alluvial and levee banks continued to erode. The 2018 results show a reduction over 2017 levels for the estuarine banks, albeit a minor reduction.

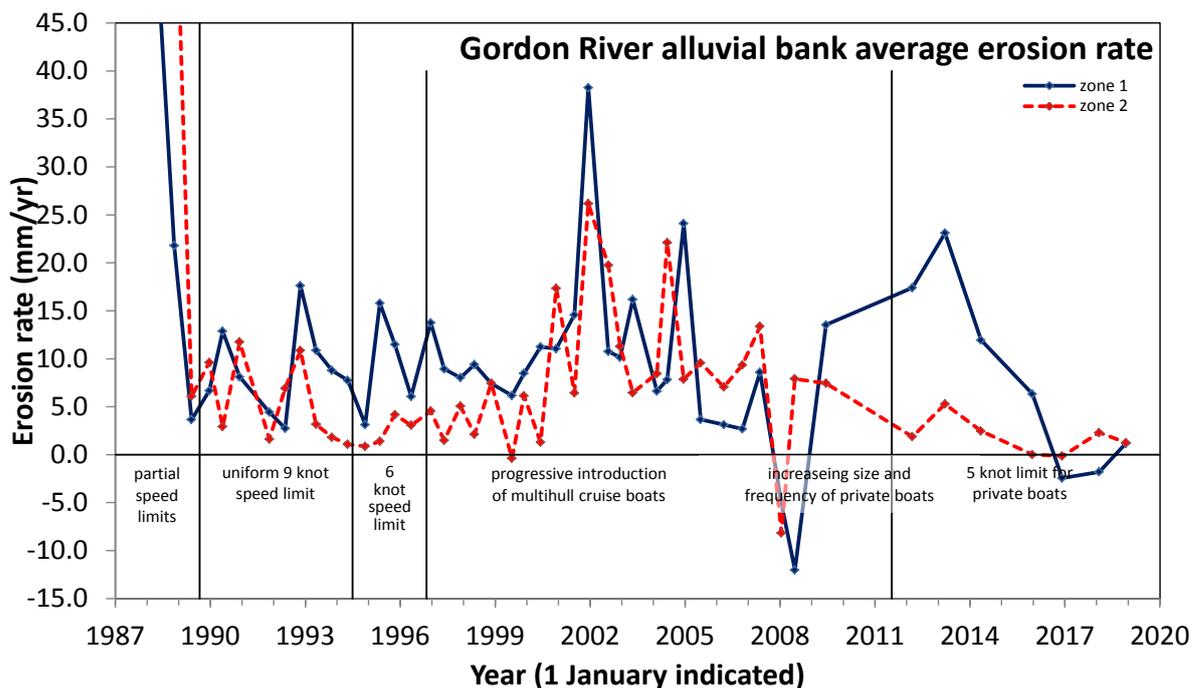
Since 1989, when commercial cruises were excluded from zone two, the rate of alluvial bank erosion in that zone has typically (but not always) been lower than that in zone one (Figure 5). That difference has been at times statistically significant and attributed to the effect of cruise boat wave wake. However for the past few years, the difference has been reversed and for the most recent monitoring period, was effectively negligible.

Figure 5: Mean rate of alluvial bank (combined scarp and flat) erosion through time

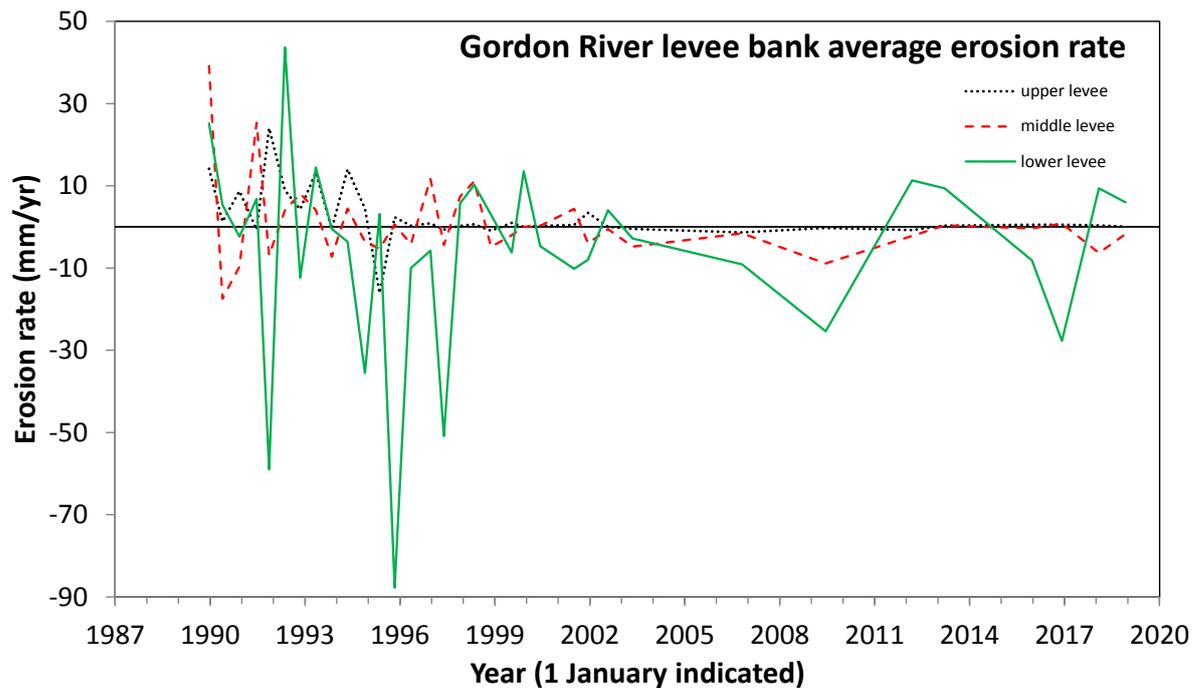
Over the 2018 monitoring period only minor adjustments of the upper and middle levee landforms were recorded. The lower levees were considerably more active, with both deposition and erosion rates in excess of 100 mm/yr being recorded for an average of 6 mm/yr erosion. Note that the time-series plot (Figure 7) appears somewhat different to previous versions. That is because when levee bank erosion experiments were done in 2008-09 the experimental sites were excluded from results because of the artificially higher rate of erosion caused by numerous experimental boat passes during the relevant monitoring period. However they were also erroneously excluded from 2012 and 2013 data sets. That error has now been corrected.

Deposition on the lower levees is limited to periods of high flow, most notably occurring during the floods of 1995 and 2007. Recent erosion therefore is of some concern, as rainfall records indicate that 2018 was a relatively wet year in the catchment. Strathgordon power station received an annual total of 3361 mm, compared to an average of 2941 mm. That included a record March daily total of 108.4 mm, not far short of the absolute maximum daily rainfall record of 125.0 mm set in 2009 (BoM 2019). Either there was insufficient flood magnitude to deliver sediment to the levee bank reaches in 2018 or there has been a recent acceleration of erosive process there.

Figure 7: Mean rate of levee bank erosion through time. Prior to 1989, when the erosion rate was much greater before cruise vessels were excluded from these reaches, no distinction was made between upper, middle and lower levee.

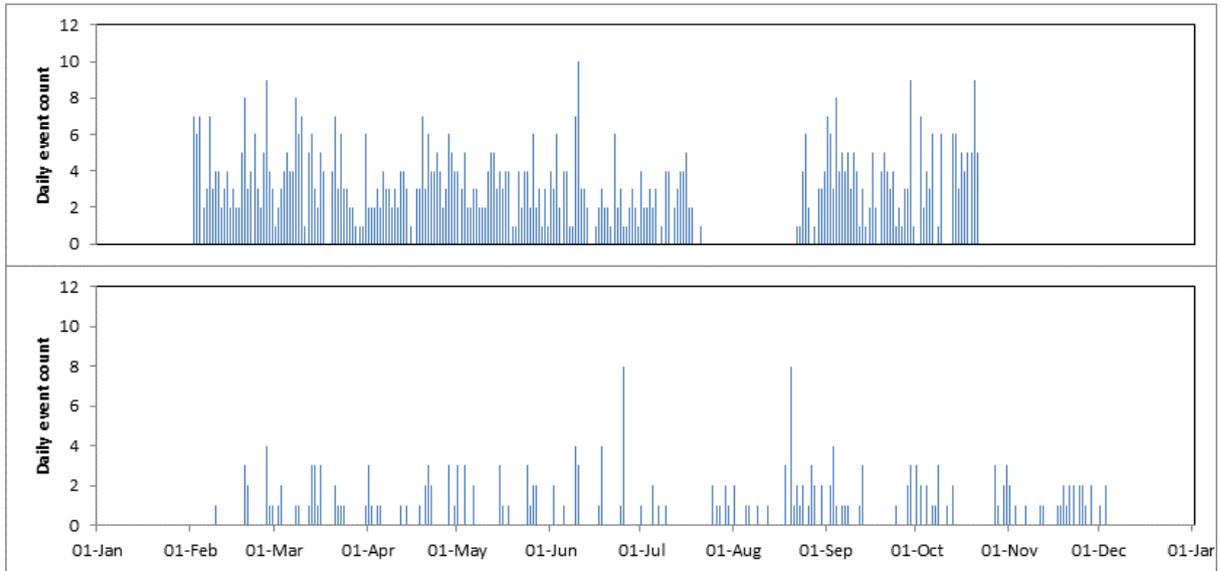
At the downstream site, a total of 755 turbidity events characteristic of wave wake impact were recorded, for an average of 3.3 per day over the 229 day operational period. The upstream site recorded 211 events, an average of 0.69 per day. Note that due to the difference in bank type (estuarine vs. alluvial) and water depth, the two sites are not directly comparable, with the upstream site being less sensitive to vessel effects. The daily event count at both sites is shown in Figure 8.

Figure 8: Histograms showing daily event counts at the two turbidity monitoring sites during 2018, downstream top and upstream bottom.

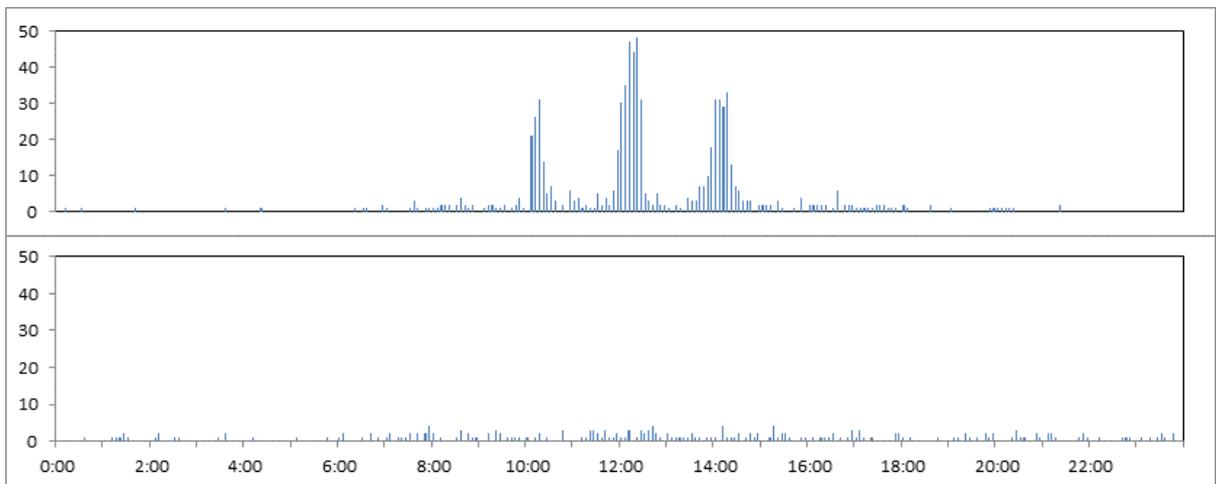
From the timing of turbidity events (Figure 9) it is clear that near bank geomorphic activity at the downstream site is still dominated by scheduled cruises, which pass the site shortly after 10:00 am (upstream), noon (upstream and downstream) and about 2:00 pm (downstream).

Figure 9: Histograms showing timing of 2018 turbidity events in 5 minute bins, downstream top and upstream bottom.

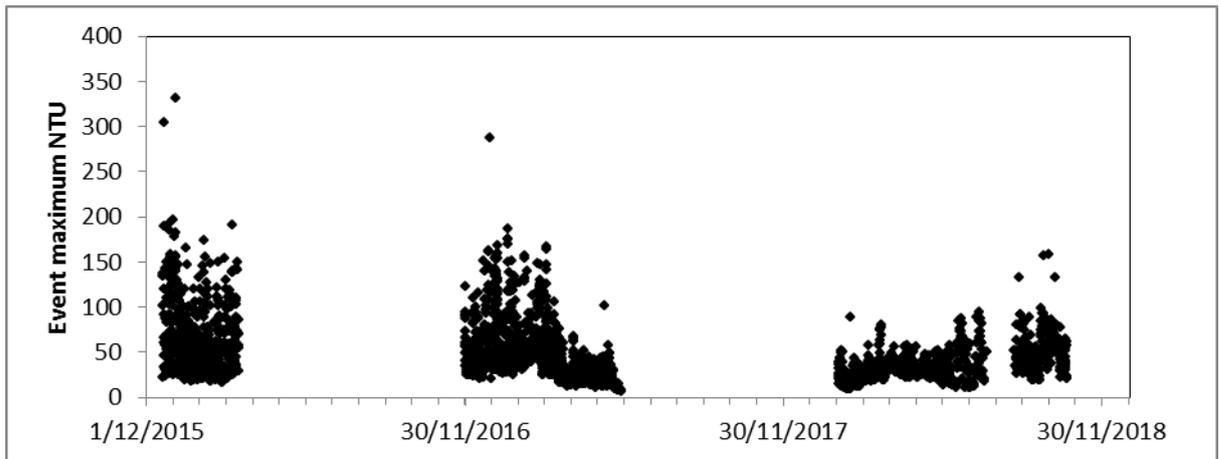
The maximum turbidity reading for each event recorded by the downstream logger since monitoring was reestablished in late 2015 is plotted in Figure 10. This shows that on average, the events of 2018 had a lower geomorphic effect than those of 2017. A one-tailed Monte Carlo randomisation test for difference in the means of the two groups indicates that the probability of observed difference in arithmetic means arising from random regrouping of the data = 0. Such a statistically significant difference between the turbidity monitoring datasets supports the above suggestion that erosion pin monitoring indicates a downturn in estuarine bank erosion rate since 2017 despite incompleteness of the erosion pin data.

Figure 10: Maximum turbidity attained for each event recorded at the downstream logging site since reinstatement in late 2015.
