Lower Gordon River erosion monitoring

Update report for the period December 2018 to January 2020

Natural Values Science Section
Natural and Cultural Heritage Division DPIWPE
July 2020

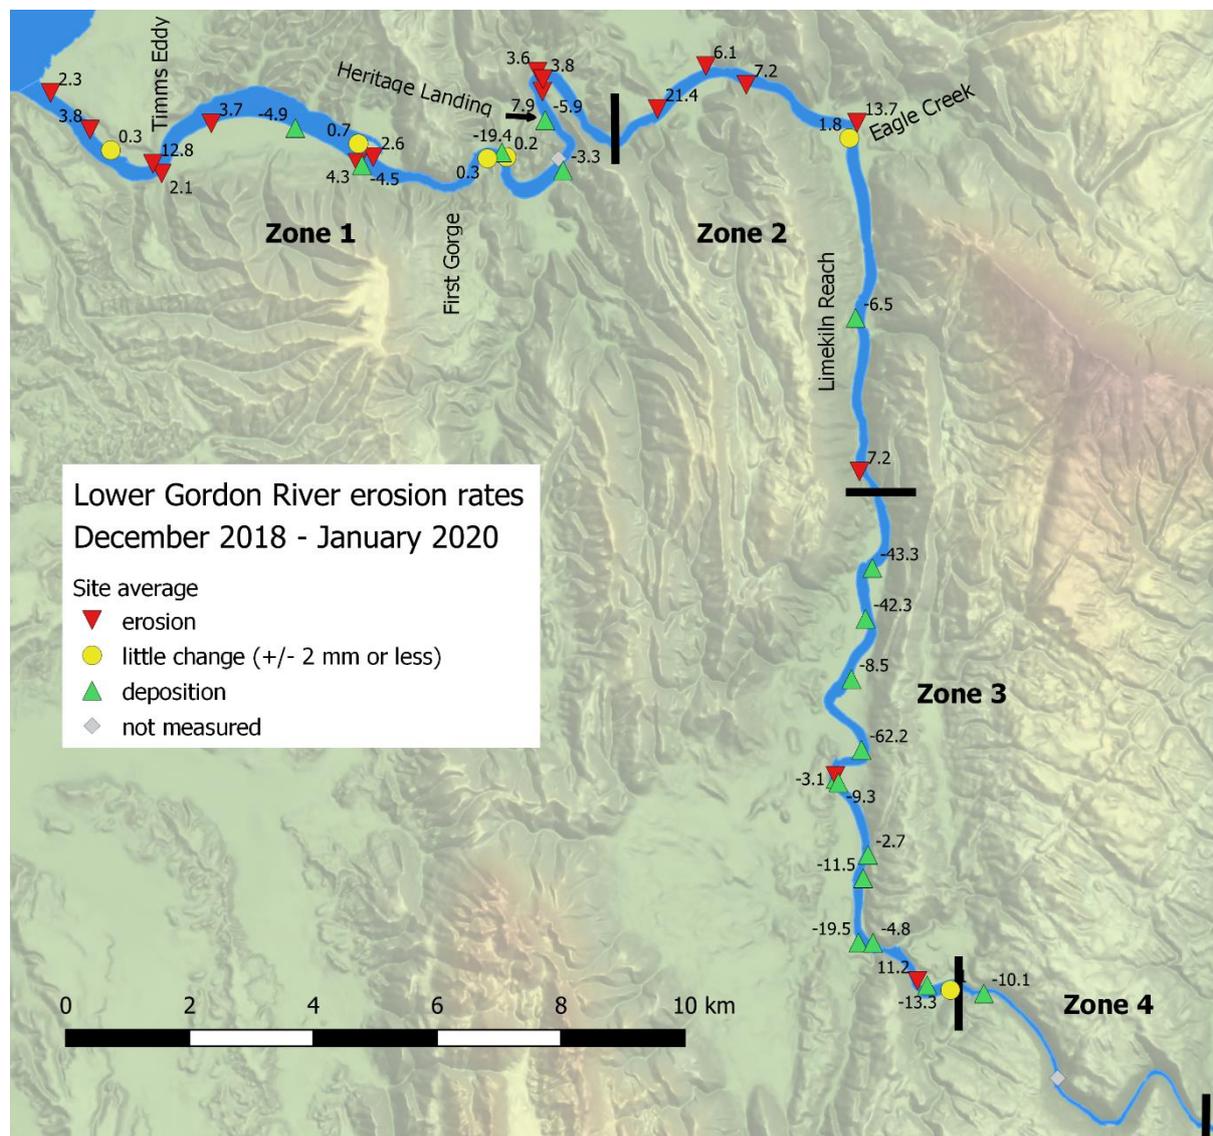
Figure 1: Map of the lower Gordon River area showing the mean rate of erosion of critical landforms (estuarine and alluvial scarps and lower levees) as recorded by multiple pins at each monitoring site. Numbers indicate the average rate of change at each site in mm/yr, zone boundaries are shown as thick black lines. Basmap ©TheLIST.

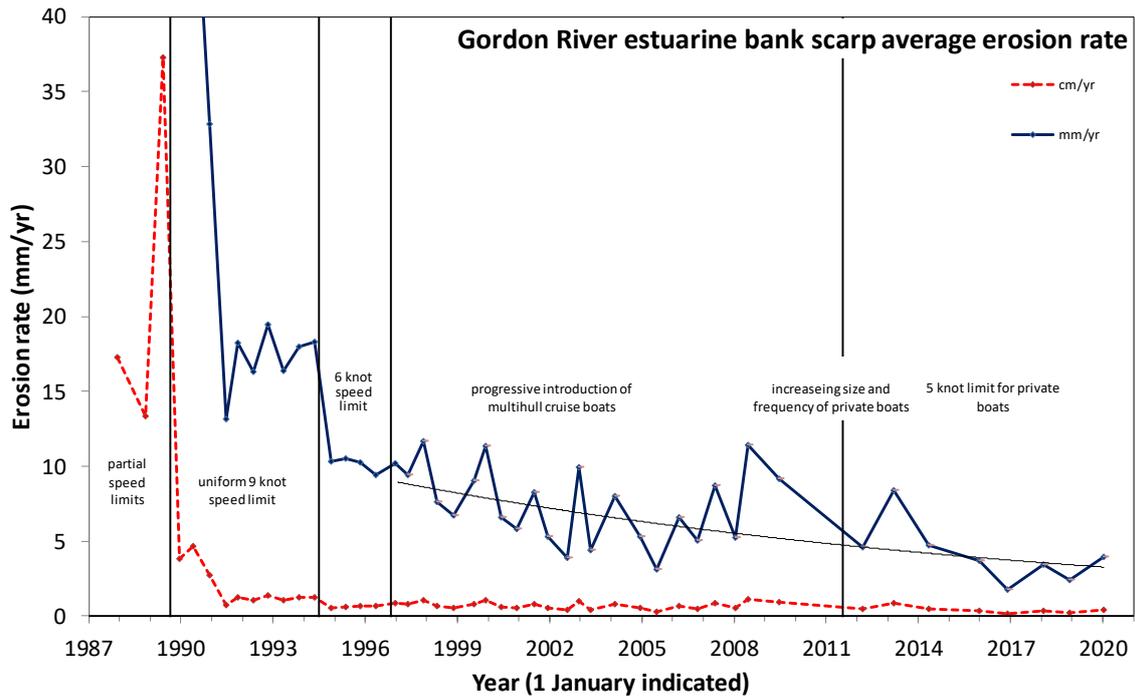
Figure 3: Mean rate of estuarine bank scarp erosion through time. In contrast to previous reports measurements from upper and lower flats are excluded, providing a better indication of bank retreat. The fine smoothed curve shows the best fit trend of the data since the first introduction of multi-hulled cruise vessels.

The formerly depositional estuarine banks recorded a slight increase in scarp erosion rate compared to the previous monitoring period. However, despite some flattening the long-term trend continues as one of declining erosion rate.

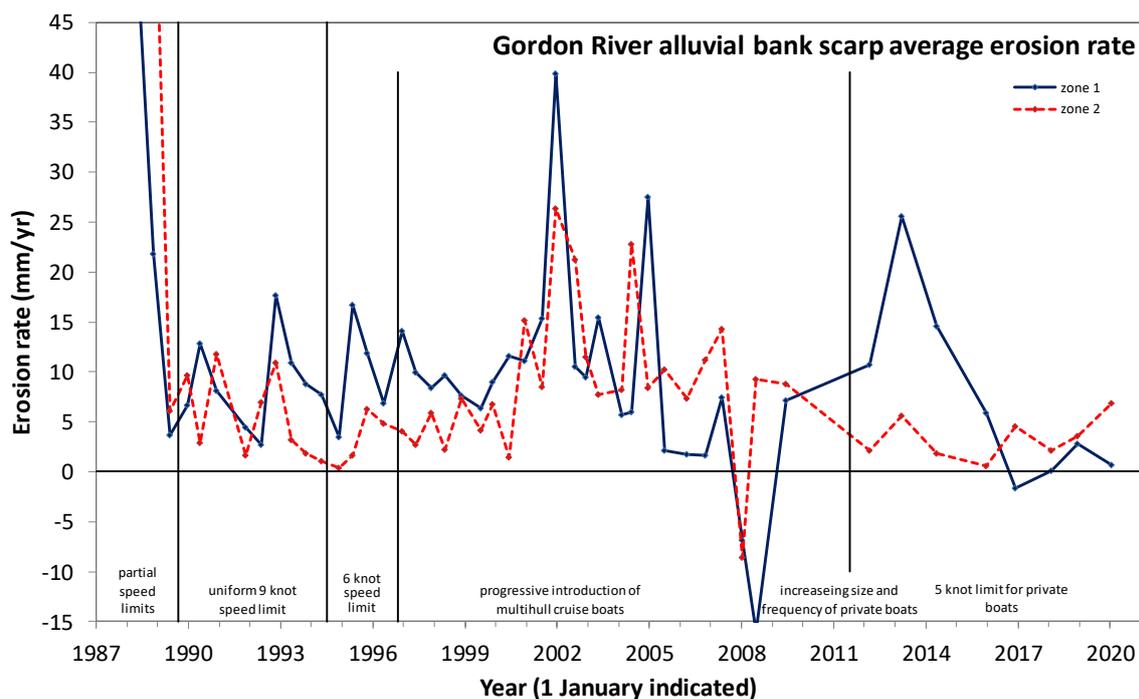
Since 1989, when commercial cruises were excluded from zone two, the rate of alluvial bank erosion in that zone has typically (but not always) been lower than that in zone one (figure 5). That difference has been at times statistically significant and attributed to the effect of cruise boat wave wake. However for the past few years the difference has been reversed, largely due to anomalously high rates of erosion in Expectation Reach. A similar situation occurred in the mid-2000s, suggesting that the banks of Expectation Reach in particular may in fact be more erosion prone than otherwise comparable banks in zone 1.

Figure 5: Mean rate of alluvial bank scarp erosion through time. In contrast to previous reports, measurements from upper and lower flats are excluded, providing a better indication of bank retreat.

Formerly stable alluvial banks in zone 1 recorded near zero average scarp erosion and deposition on both upper and lower flats. However similar banks in zone 2 showed the highest average rate of scarp retreat in a decade and recorded erosion of both upper and lower flats. The long-term data suggests that the banks of Expectation Reach in particular may in fact be more erosion prone than otherwise comparable banks in zone 1.

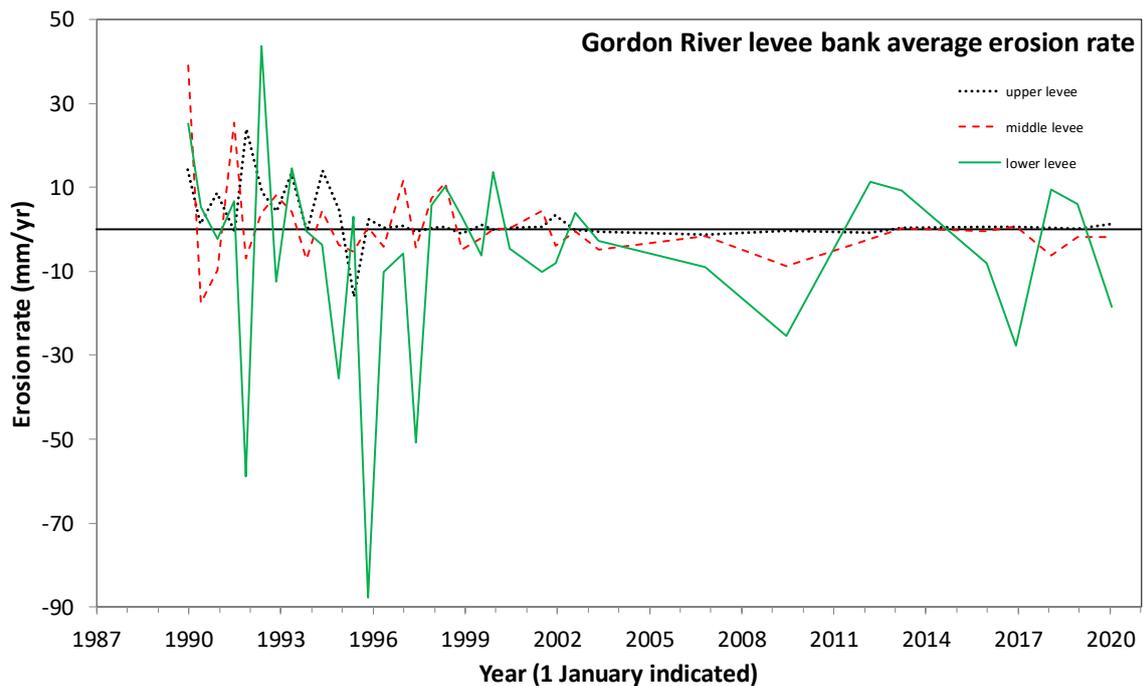
Over the 2019 monitoring period only minor adjustments of the upper and middle levee landforms were recorded. The lower levees were considerably more active, with significant rates of both deposition and erosion being recorded, for an average of 19 mm/yr deposition. Since closure of the leveed reaches to commercial cruises in 1989 the lower levees have recorded an average of almost 200 mm of cumulative deposition. However, that is an underestimate of true deposition for two reasons:

Figure 7: Mean rate of levee bank erosion through time. Prior to 1989, when the erosion rate was much greater before cruise vessels were excluded from these reaches, no distinction was made between upper, middle and lower levee.

Levee bank scarps and debris aprons showed little activity, as might be expected. In contrast to the previous year the scarp foot recovery bars recorded deposition of up to 131 mm/yr for an average of 19 mm/yr. These banks continue their slow recovery from the catastrophic erosion of the 1980s but do not yet show any evidence for the development of a protective surficial root mat.

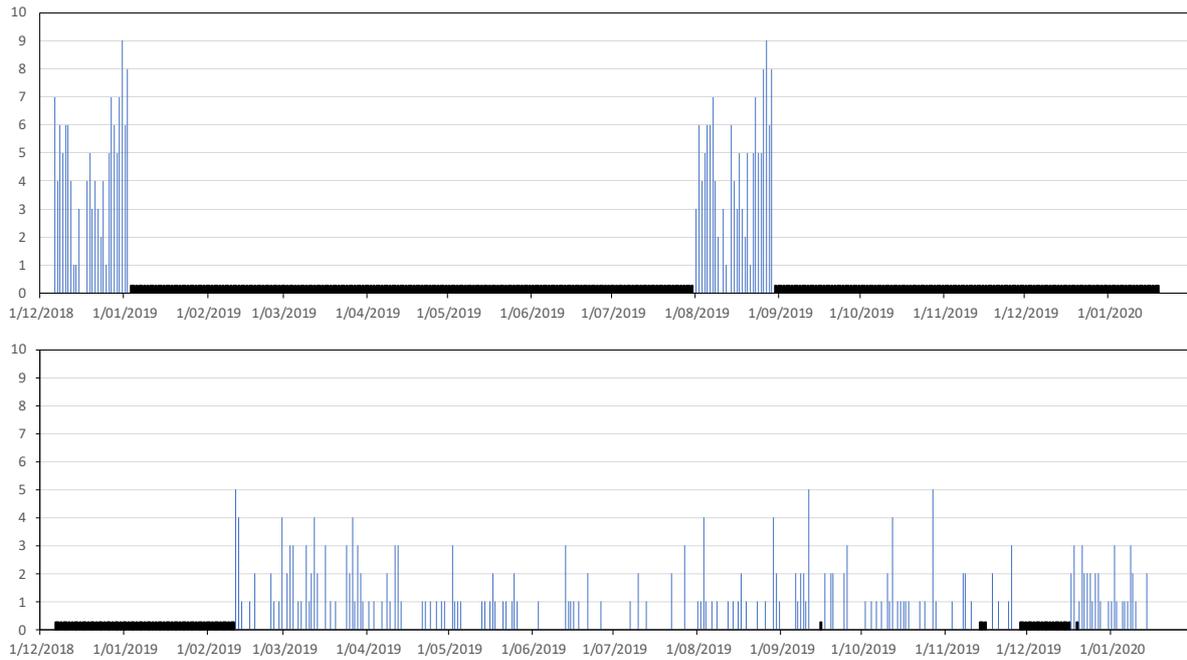
The monitoring period 7 December 2018 to 16 January 2020 contained 405 days. Of those the upstream site recorded data for 313 days while the downstream site only recorded 56 days of data. In addition, time and date stamps for the August 2019 data from the downstream logger are suspect. Data loss was mostly due to datalogger malfunction, with an additional 24 days loss from the upstream site due to excessively noisy signal of unknown cause. The malfunctioning and by now obsolescent devices were replaced with new Unidata Neon 3004A loggers in January 2020.

At the downstream site a total of 251 turbidity events characteristic of wave wake impact were recorded, for an average of 4.48 per day over the 56 days of operation. The upstream site recorded 211 events, an average of 0.73 per day. The daily event counts at both sites are shown in figure 8 and are consistent with previous tallies. Note that due to the difference in bank type (estuarine vs. alluvial) and water depth the two sites are not directly comparable, with the upstream site being less sensitive to vessel effects.

Figure 8: Histograms showing daily event counts at the two turbidity monitoring sites during the monitoring period, downstream top and upstream bottom. Thick black bars indicate periods of data loss.

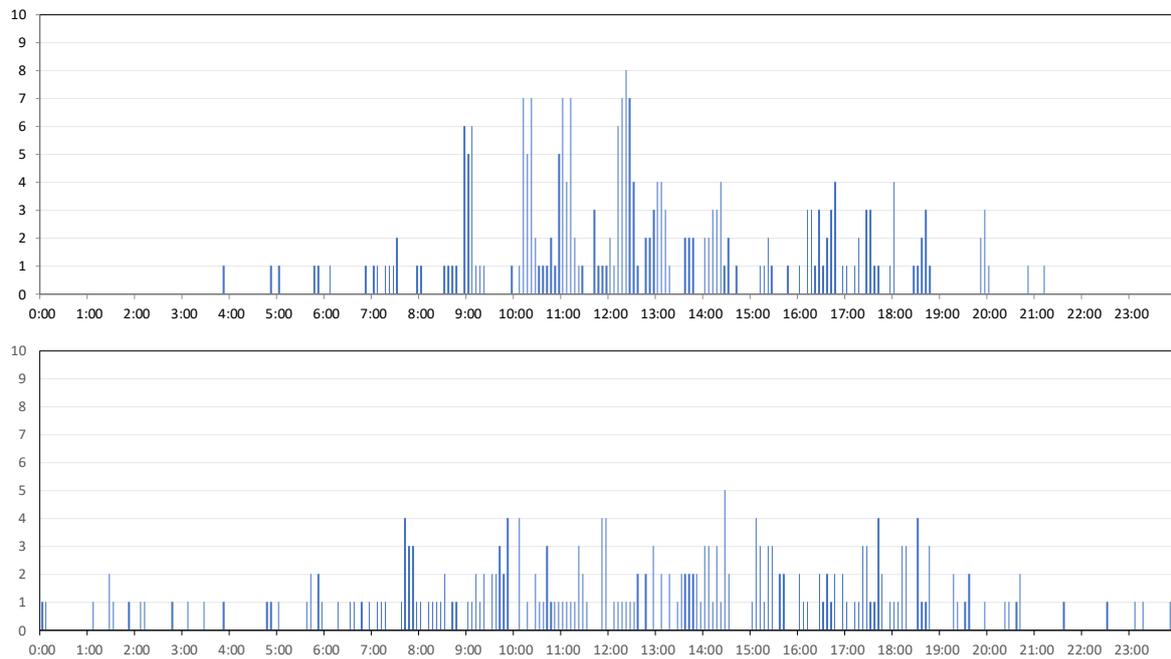
Historically, the timing of turbidity events (figure 9) has shown that near bank geomorphic activity at the downstream site is dominated by scheduled cruises, which pass the site shortly after 10:00 am (upstream), noon (upstream and downstream) and about 2:00 pm (downstream). While that remained the case for the December 2018 data, the August 2019 data shows a similar pattern but approximately an hour earlier. It is not clear whether that represents a true pattern of use or corrupt time and date stamping as a by-product of logger failure.

Figure 9: Histograms showing timing of turbidity events in 5-minute bins during the monitoring period, downstream top and upstream bottom.
