**Index of River Condition
for the
Pipers River Catchment**

Mark Nelson,
Aquatic Ecologist
Land and Water Management Branch
Resource Management and Conservation Division
DPIWE.

Report Series WRA 99/22
December, 1999.

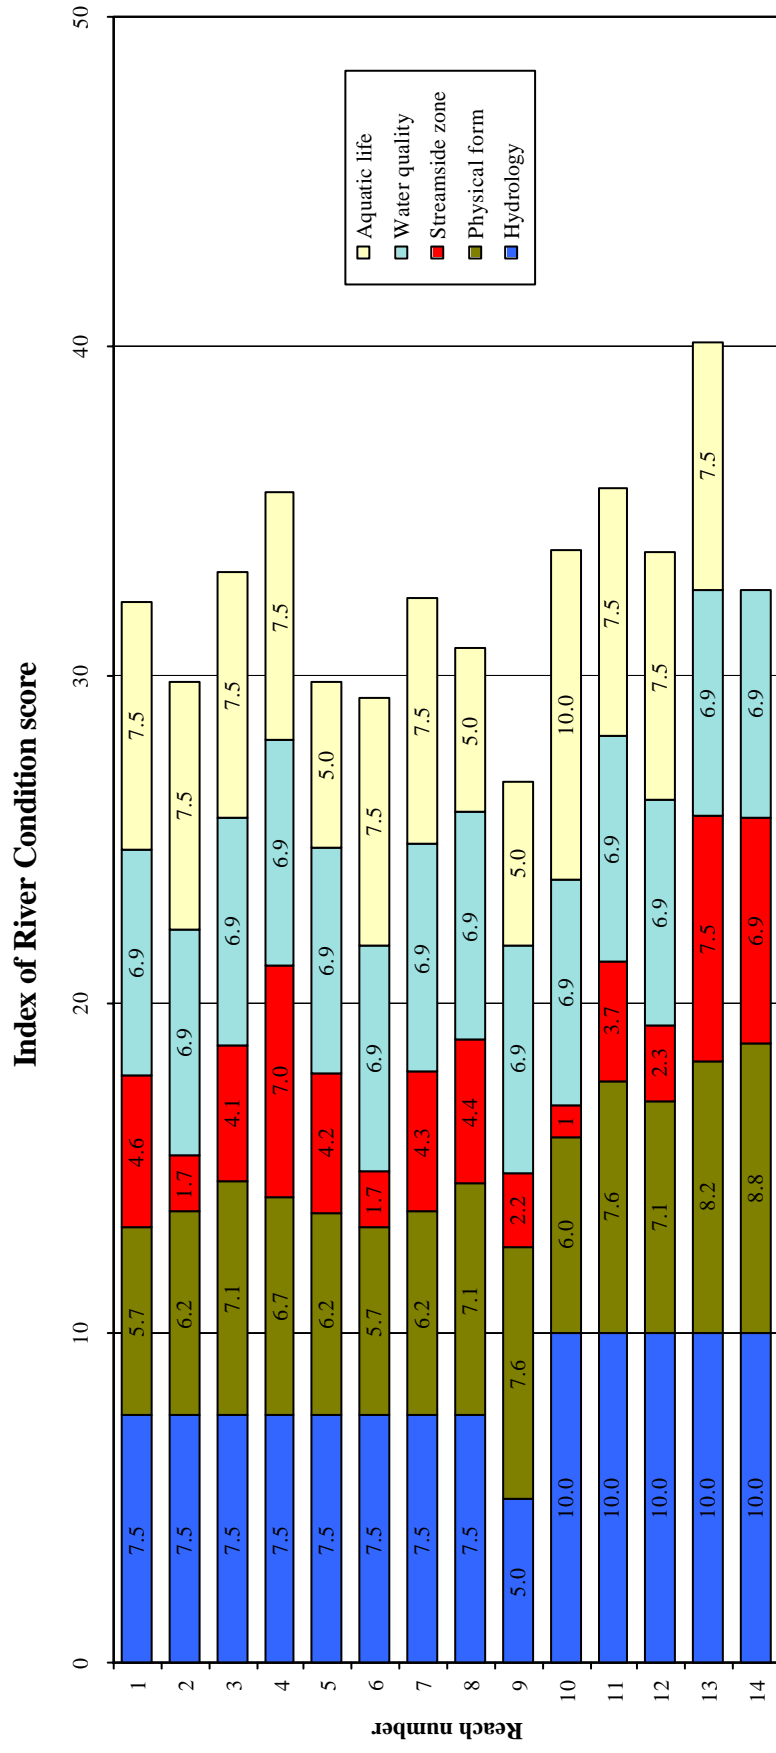
Figure 3. IRC results for the Pipers River main-stream sites.

- The IRC scores illustrate a gradual increase in quality up the catchment. There is a slight drop in condition within the middle catchment (sites 5 to 9), but from sites 10 to 14 all improve to a level of near natural or good condition. The average condition of the entire catchment rates out as in good condition overall. In summary, 4 sites (2, 5, 6 & 9) rate as showing some modification and the remainder rate as in good condition (near natural) except site 13 at the top of the catchment which rated within the essentially natural band (excellent condition).

- The hydrology sub-index rated well for the mainstream with 5 out of 14 sites in excellent condition (upper catchment), 8 sites (1 to 8, mid to lower catchment) in good condition (near natural) and the remaining site (9) in moderate condition (some modification). The greatest level of water extraction occurs in the tributary streams in the middle of the catchment (largely Second R. and its tributaries) and therefore all the mainstream sites above the confluence (sites 10 to 14) were unimpacted.

- Physical form sub-index rated as in good condition (near natural) throughout much of the catchment with site conditions ranging between moderate (1, 6 & 10), good condition (2 - 5, 7 - 9, 11 & 12) and excellent condition for the top 2 sites (13 & 14).

- The streamside zone sub-index scores rated poorly on average throughout the catchment with some sites exhibiting scores of less than 2 indicating highly modified or very poor conditions (sites 2, 6 & 10). Of the remaining 14 sites 3 were in poor (major modification) condition, 5 were in moderate (some modification) condition and 3 were in good (near natural) condition. No sites rated as in essentially natural condition. Overall the condition of the mainstream streamside zone was variable throughout the catchment with only one site in the lower catchment (4) and the top 2 sites (13 & 14) standing out as in good condition. This sub-index also clearly stood out as the most modified as illustrated in Table 12.

- Water quality at all sites rated consistently as in good condition (near natural). All sites ranked the same and no site stood out as impacted to any great degree. Overall pH was essentially neutral, conductivity ranged between 150 to 180 $\mu\text{S}/\text{cm}$ and turbidity was low (4 to 6 NTU's). Final analysis was derived from a limited data set and this may explain the consistency of the scores.

- IRC results suggest that aquatic life within the main-stream is in reasonable condition with 9 of the 14 sites exhibiting good (near natural) conditions, 3 sites (5, 8 & 9) in moderate (some modification) condition and 1 site (10) in excellent (essentially natural) condition. No data was collected from site 14 due to lack of flow.

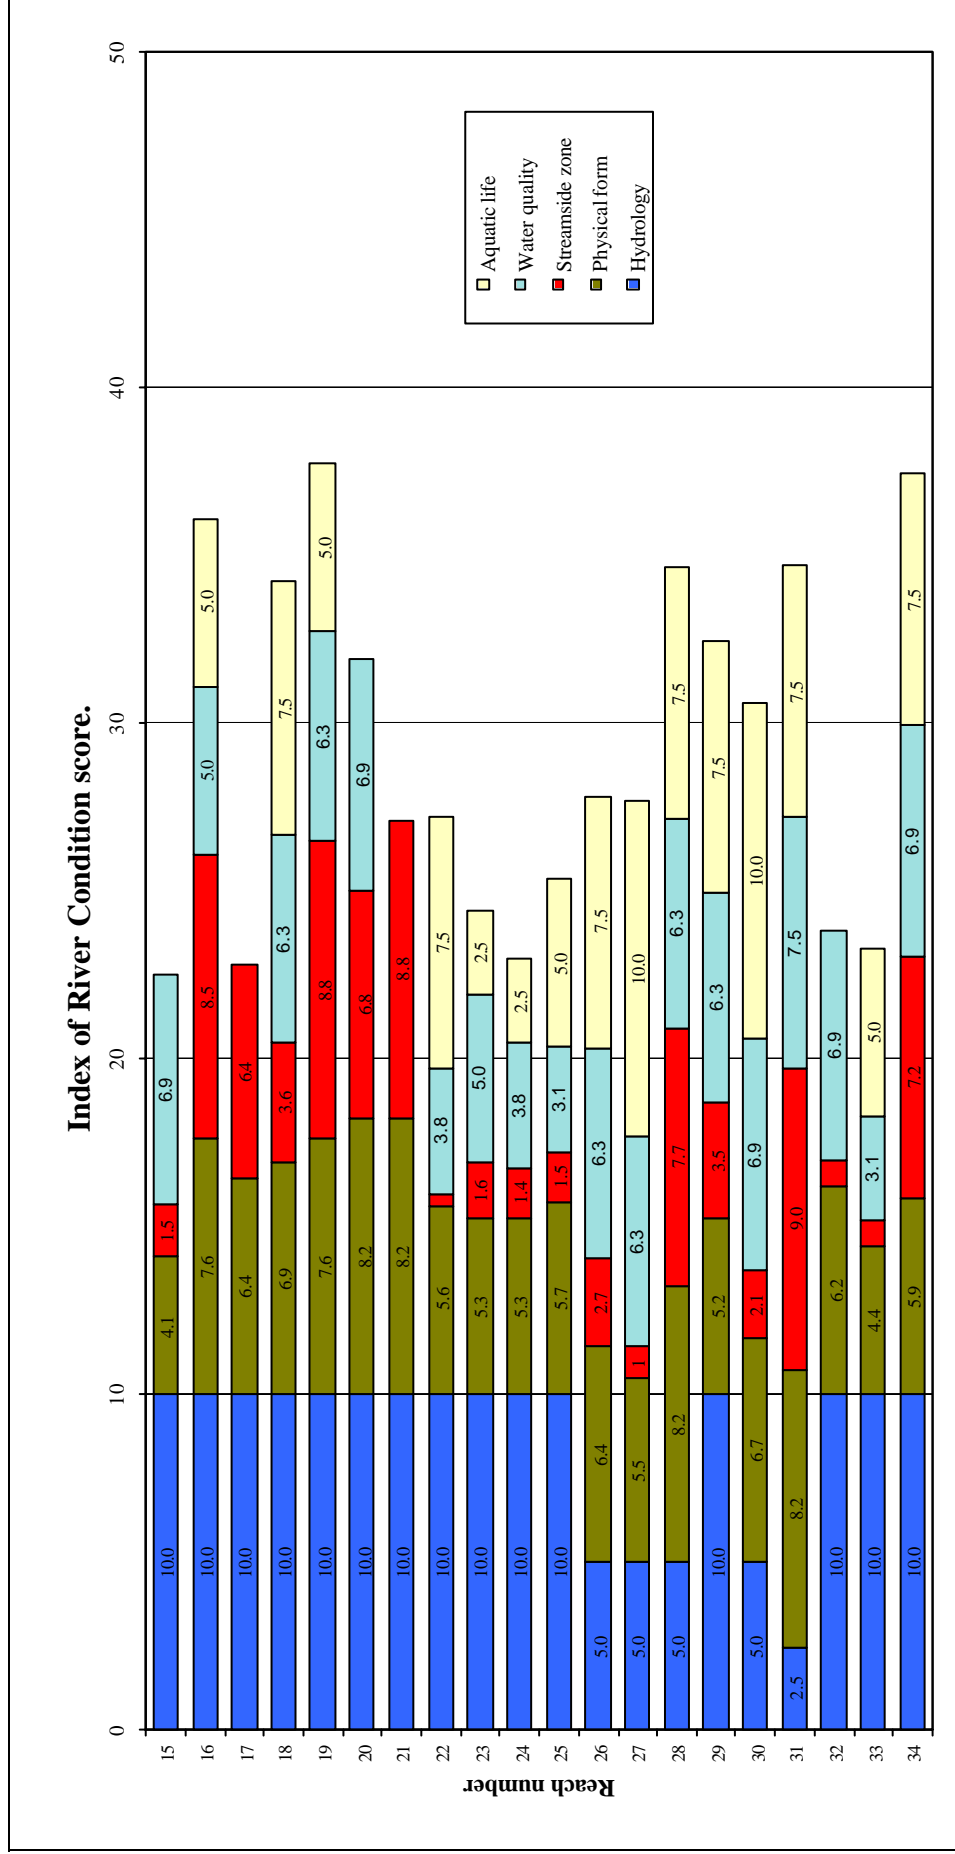
Figure 4. IRC results for the Pipers River tributaries.

- The average condition of the tributary streams rated as in good condition (near natural) but all final scores were borderline between some modification and good condition (refer to Table 12). Of the 20 sites assessed, 11 rated as in moderate condition and 9 rated as in good condition (near natural). There was no clear pattern of improving condition in the tributary streams throughout the main catchment. Individual tributaries exhibited improved conditions in their upper catchments. For example, Montgomery Ck (sites 18 & 19), Second River (sites 23 & 24) and Rocky Ck (sites 30 & 31) all showed improved conditions at upper sites, while Third River (sites 23 & 24) and Hogans Ck (sites 32 & 33) did not.

- In general, physical form sub-index rated as in good condition (near natural) throughout the catchment with site conditions ranging between moderate condition (15, 22 - 25, 27, 29, 33 & 34), good condition (16 - 19, 26, 30 & 32) and excellent condition (20, 21, 28 & 31).

- The streamside zone sub-index varied considerably amongst the tributary streams but did not rate highly overall (overall average of moderate condition, Table 12). The most impacted site (22) was Colgrave Ck at Pipers River Rd, which had an extremely low rating of 0.4 (highly modified, very poor condition). 7 other sites also fell within this rating of very poor condition (sites 15, 23, 24, 25, 27, 32 & 33). 4 sites (18, 26, 29 & 30) rated as in poor condition 4 as in good condition (17, 20, 28 & 34) with the remaining 4 sites (16, 19, 21 & 31) rating as essentially natural. Both sites on Hogans River (32 & 33) rated as in very poor condition. Rocky Ck (30 & 31) was in poor condition in its lower catchment but essentially natural in the upper reaches. This pattern was also evident for the Second River (26, 27 & 28) and Montgomery Ck (18 & 19) sites. In all highly impacted sites, riparian width and regeneration of indigenous species was minimal to non-existent, while structural intactness, proportion of indigenous cover, longitudinal continuity and streamside cover were all highly modified.

- The Water quality sub-index rated reasonably well within the tributary sites. The average condition was moderate (some modification). 4 sites (22, 24, 25 & 33) out of the 20 assessed, rated as in poor condition (major modification), 2 sites (16 & 23) were in moderate condition, while the remaining 11 sites (15, 18-20, 26-32 & 34) rated as in good condition. All the water ways were slightly acidic (<7) and the majority had slightly elevated conductivity readings (i.e. over 100 $\mu\text{S}/\text{cm}$). Site 25,

- The Aquatic life sub-index rated as in moderate condition (some modification) overall. Sites 27 and 30 rated as in excellent condition (essentially natural), while sites 23 and 24 were assessed as reflecting major modification. Of the remaining sites, 4 were in moderate condition (16, 19, 25 & 33) and 7 rated as in good condition (18, 22, 26, 28, 29, 31 & 34).
- Data gaps present for the tributary stream sites were minimal with information missing from sites 15, 17, 20, 21 and 32. Sites 17 and 21 had water quality and instream faunal parameters missing due to dry conditions. Water quality information for sites 15, 20 and 32 came from the Water Quality study of the State of Rivers report but no flow at the time of sampling inhibited the collection of faunal data.

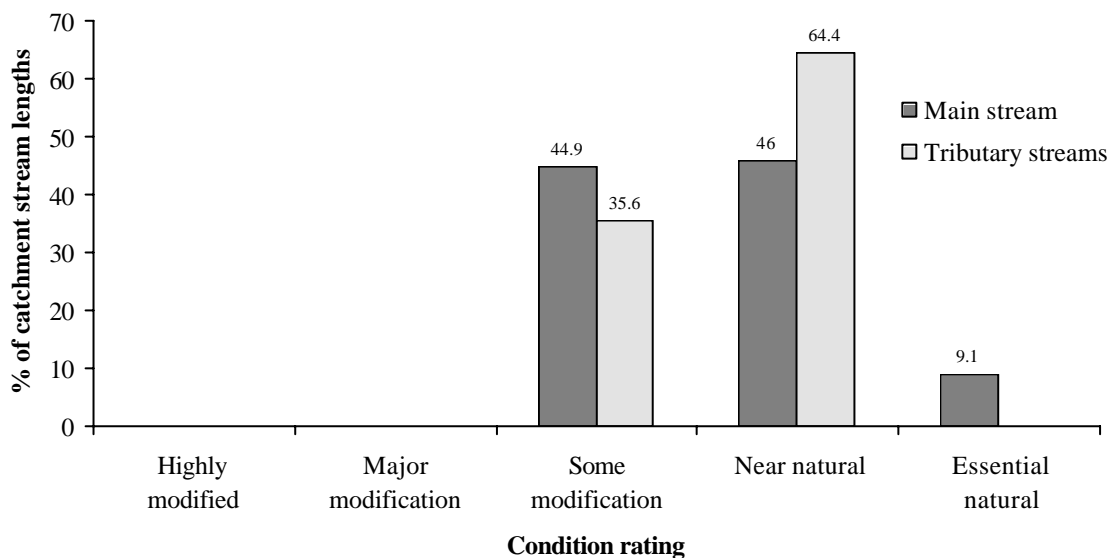
Figure 5. Overall river condition.

An examination of the overall condition ratings for both tributary and main-stream lengths reveals no section with a high or major modification to condition. But conversely only one site came out as essentially natural (site 13) and this also was borderline. Figure 5 details the rating structure of the proportion of stream lengths within the catchment. The data in that chart shows that 45% of the main-stream has some modification to condition while 46% is near natural and 9% is essentially natural (one reach only) with 5 of the near natural sites at the top of the catchment and the rest scattered through the remainder (refer to Fig. 2 and 3). For the tributary streams, 35% fall into the category of some modification to condition, while the majority (64%) show near to natural conditions. In general, it was estimated that 40% of all the catchment streams have some modification from natural conditions and the remaining 60% are near natural. But, as detailed above, sub-index parameters within each final rating structure may vary considerably from site to site indicating the potential problems that lie within each reach.

Catchment conditions are frequently characterised by impacted condition in the lower catchment and improved conditions higher in the catchment. This clearly occurs in the Pipers River catchment, with the top 5 sites rating as near natural, although actual scores within the near natural rating do not rank highly (Fig. 3). Site 13 is the only site within the entire catchment that ranks as essentially natural. In general the rating scores vary around the near natural/some modification boundary through the length of the mainstream in particular (Fig. 3). The majority of the tributary streams rated as near natural but once again scores varied considerably throughout the catchment. Second River sites (26, 27 and 28) improved in condition up the catchment. Two thirds of the Pipers River catchment is modified by agricultural activities. The very top of the catchment is well forested as are some sections in the middle of the catchment.

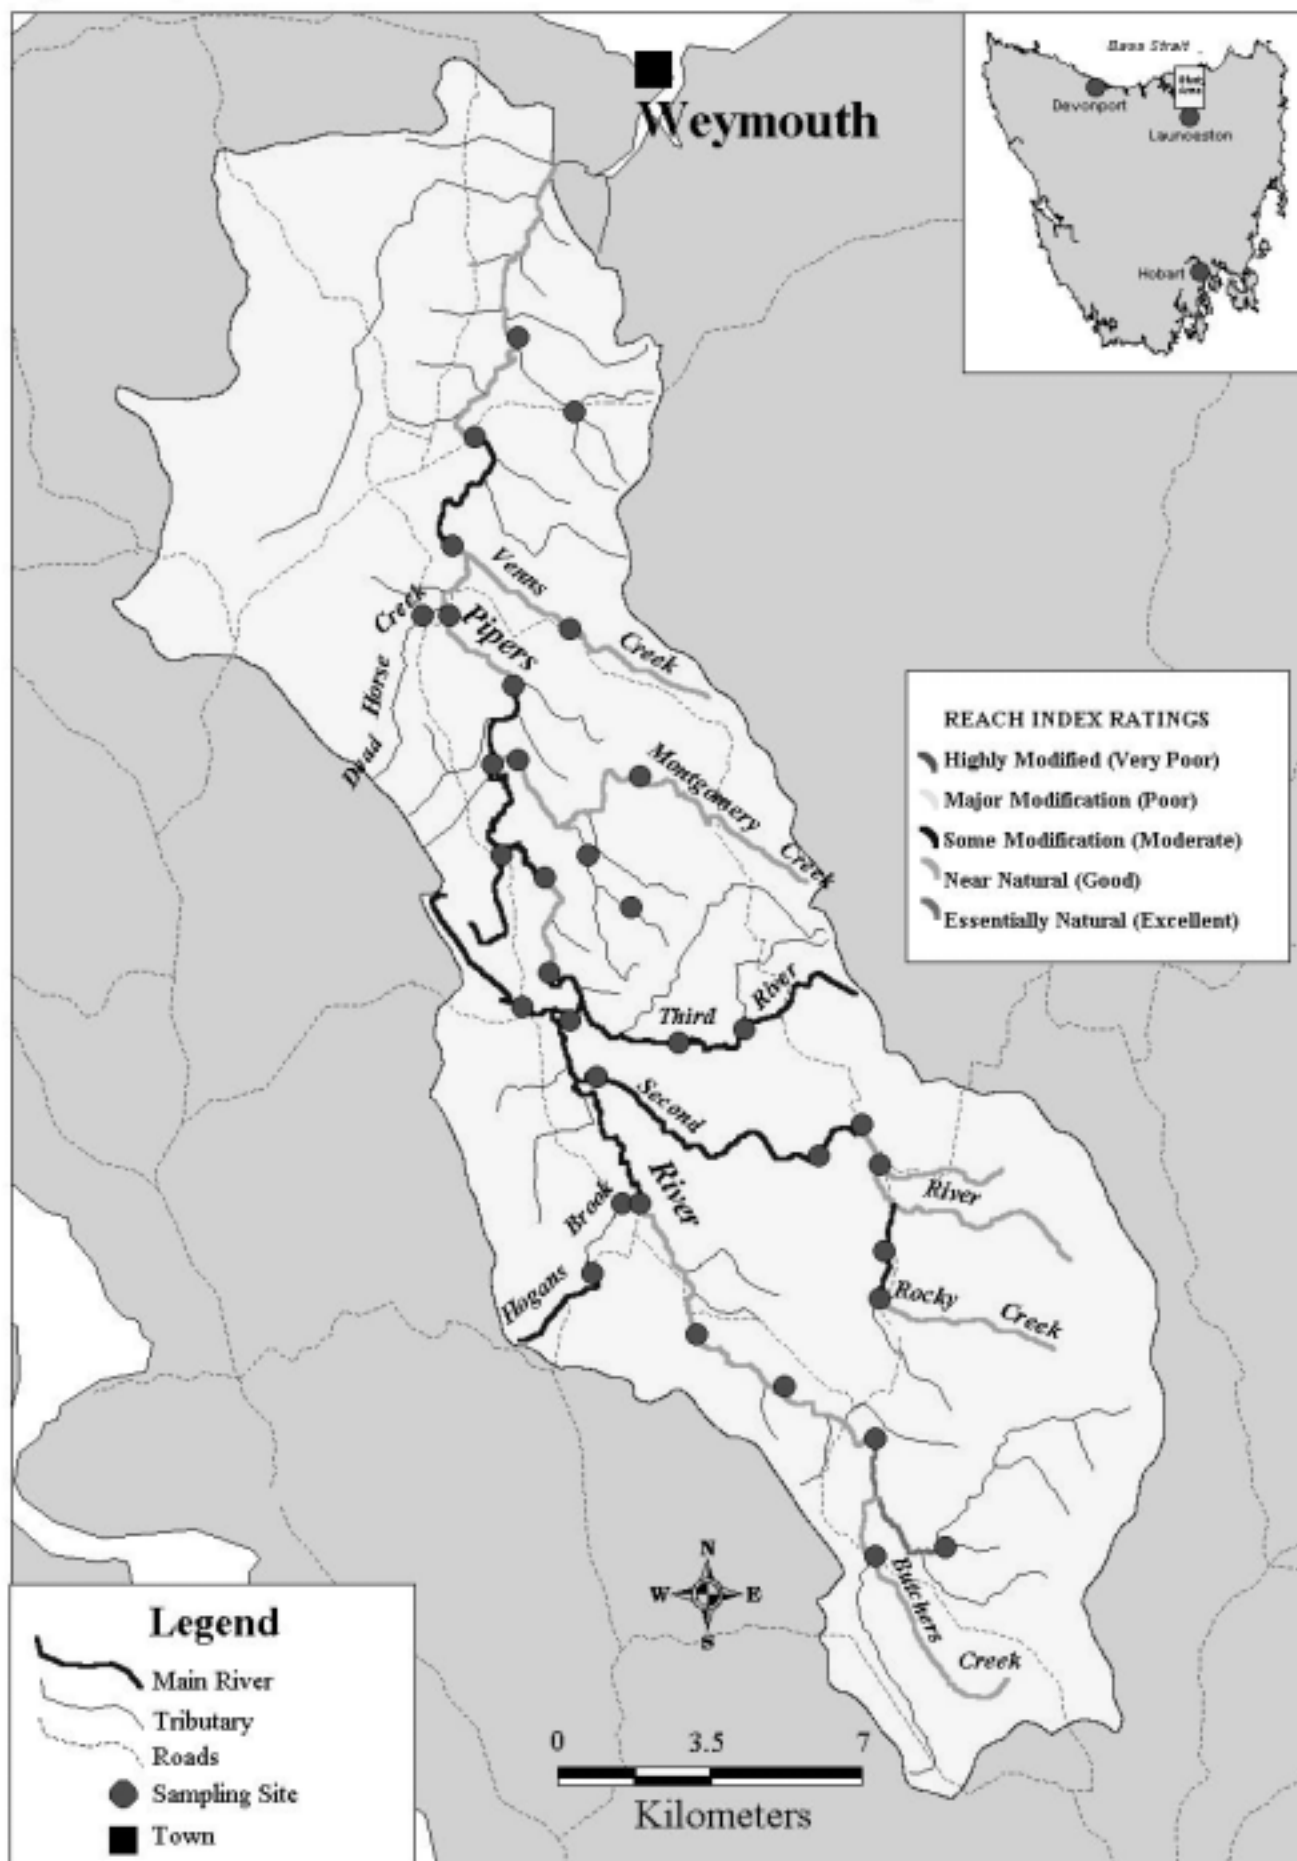
Figure 6: Pipers River Catchment. Overall Reach Condition Ratings

Figure 6 graphically illustrates the distribution of overall condition ratings for stream length within the catchment. The information is limited by the location of study sites and stream length condition is an extrapolation of site information. Only major tributaries and the main-stream river were targeted. The information available indicates that the overall condition of the catchment is one of moderately impacted environment with the lowest score of moderate or some change from natural or ideal conditions. As detailed above, sub-index parameters within each final rating structure may vary considerably from site to site.
