DEPARTMENT of
PRIMARY INDUSTRIES,
WATER *and* ENVIRONMENT

Index of River Condition for the North Esk River Catchment

David Horner
Aquatic Ecologist
Water Assessment and Planning Branch
DPIWE.

December, 2003.

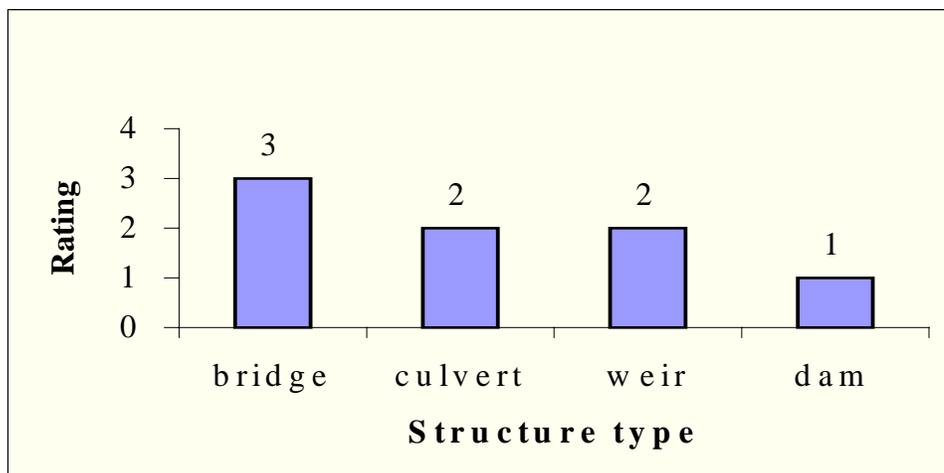
Figure 4. Median rating values for different barrier types assessed within the North Esk catchment.

Figure 4 presents ratings for various types of structures in relation to hydrological connectivity. Essentially, bridges result in partially modified conditions, culverts and weirs result in moderately altered conditions and farm dams result in poor conditions for fish passage. Table 4 indicates that overall, the catchment as a whole and the mainstream provide "Near ideal" conditions for fish passage. As on-stream storages are almost exclusively located on associated tributaries, smaller order streams provide only "moderate" condition for passage. Figure 9 shows the distribution of structures and related fish passage values of structures that were surveyed within the catchment.

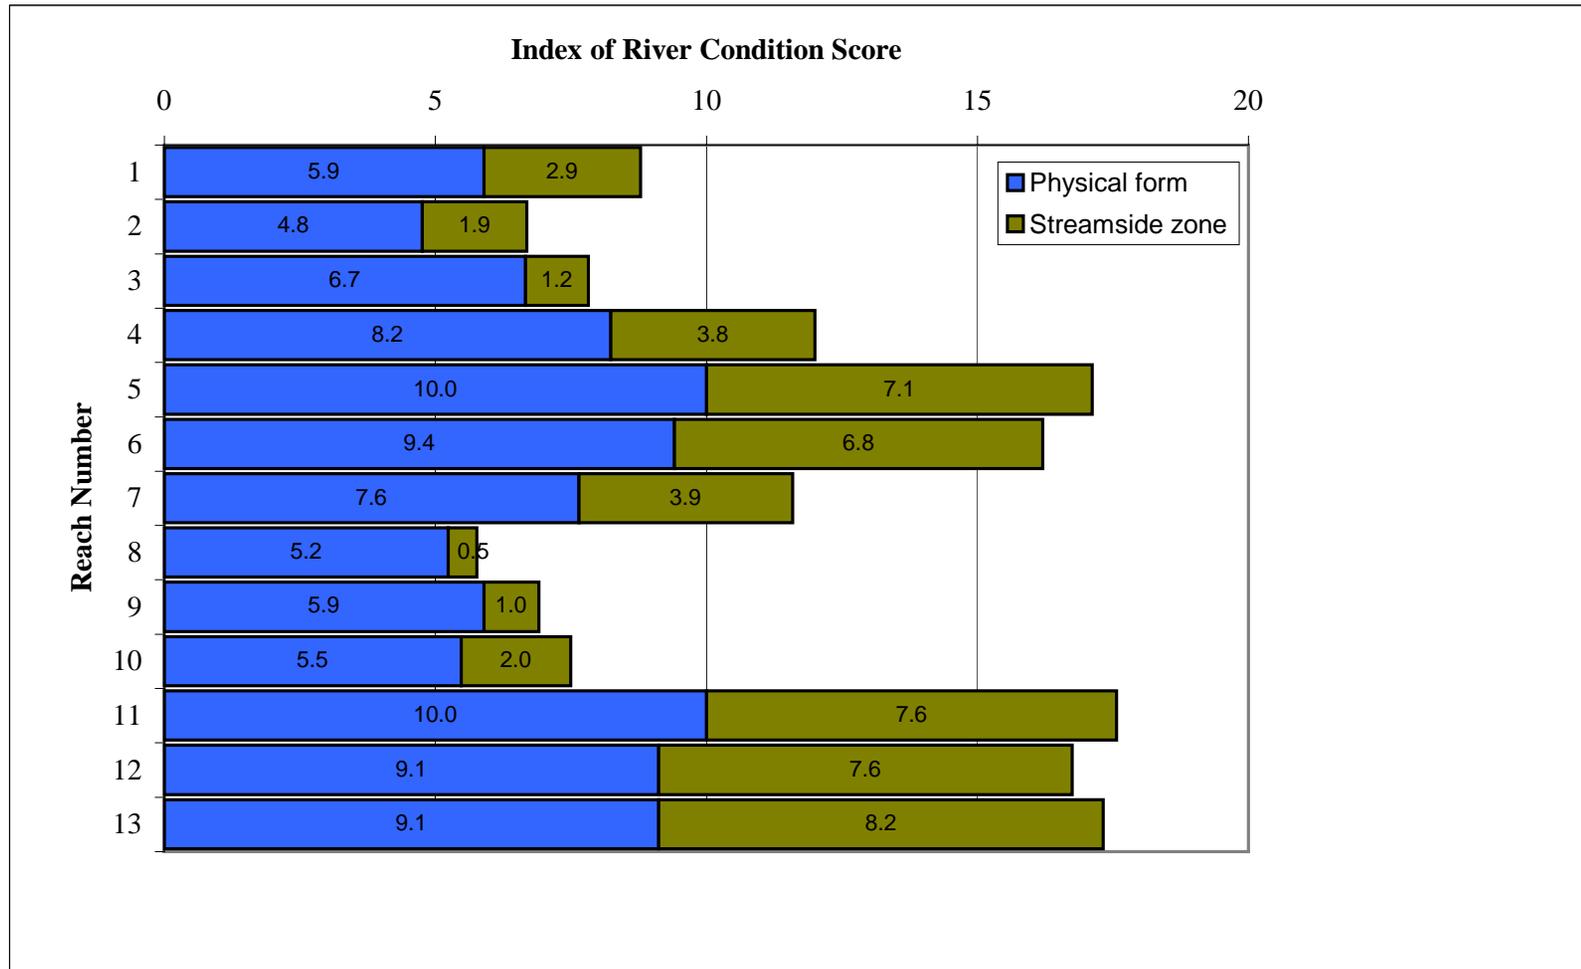
Figure 5. IRC results for the North Esk River mainstream sites.

The stream side index clearly stood out as the most modified as illustrated in Figure 5. Overall, the average stream-side zone sub-index rating for the main stream is of moderate condition. The condition of stream-side vegetation in the mainstream varied between reaches and like physical form ratings reflected adjacent land use practices. In agricultural and urban areas there was a trend for reduced ratings, indicating a higher degree of modification. This is highlighted in the lower catchment where Site 2 (North Esk upstream of Clarks Ford Bridge) and Site 3 (North Esk below Corra Linn) rated as in very poor condition, and Sites 1 (North Esk downstream of the confluence with Kings Meadow Rivulet) and Site 4 (North Esk at Corra Linn) rated as in poor condition. Near natural conditions were recorded for Sites 5 (North Esk at White Hills) and Site 6 (North Esk upstream of the St Patricks River confluence) which occur within areas that are adjacent to land not intensely used for agriculture. Moderate condition was recorded for the North Esk at Ballroom (Site 7). Site 8 (North Esk at Musselboro Road), Site 9 (North Esk at Burns Creek Road) and Site 10 (North Esk at Wattle Corner (Camden Road)) are clearly affected by surrounding land usage, with Sites 8 and 9 rating as in very poor condition and Site 10 in poor condition. The top 3 sites (North Esk of Camden Road to North Esk above "Northallerton") are upstream of agricultural and urban impacts and stand out as in good (Sites 11 and 12) to excellent condition (Site 13). This sub-index clearly stood out as the most modified as illustrated in Appendix 2.

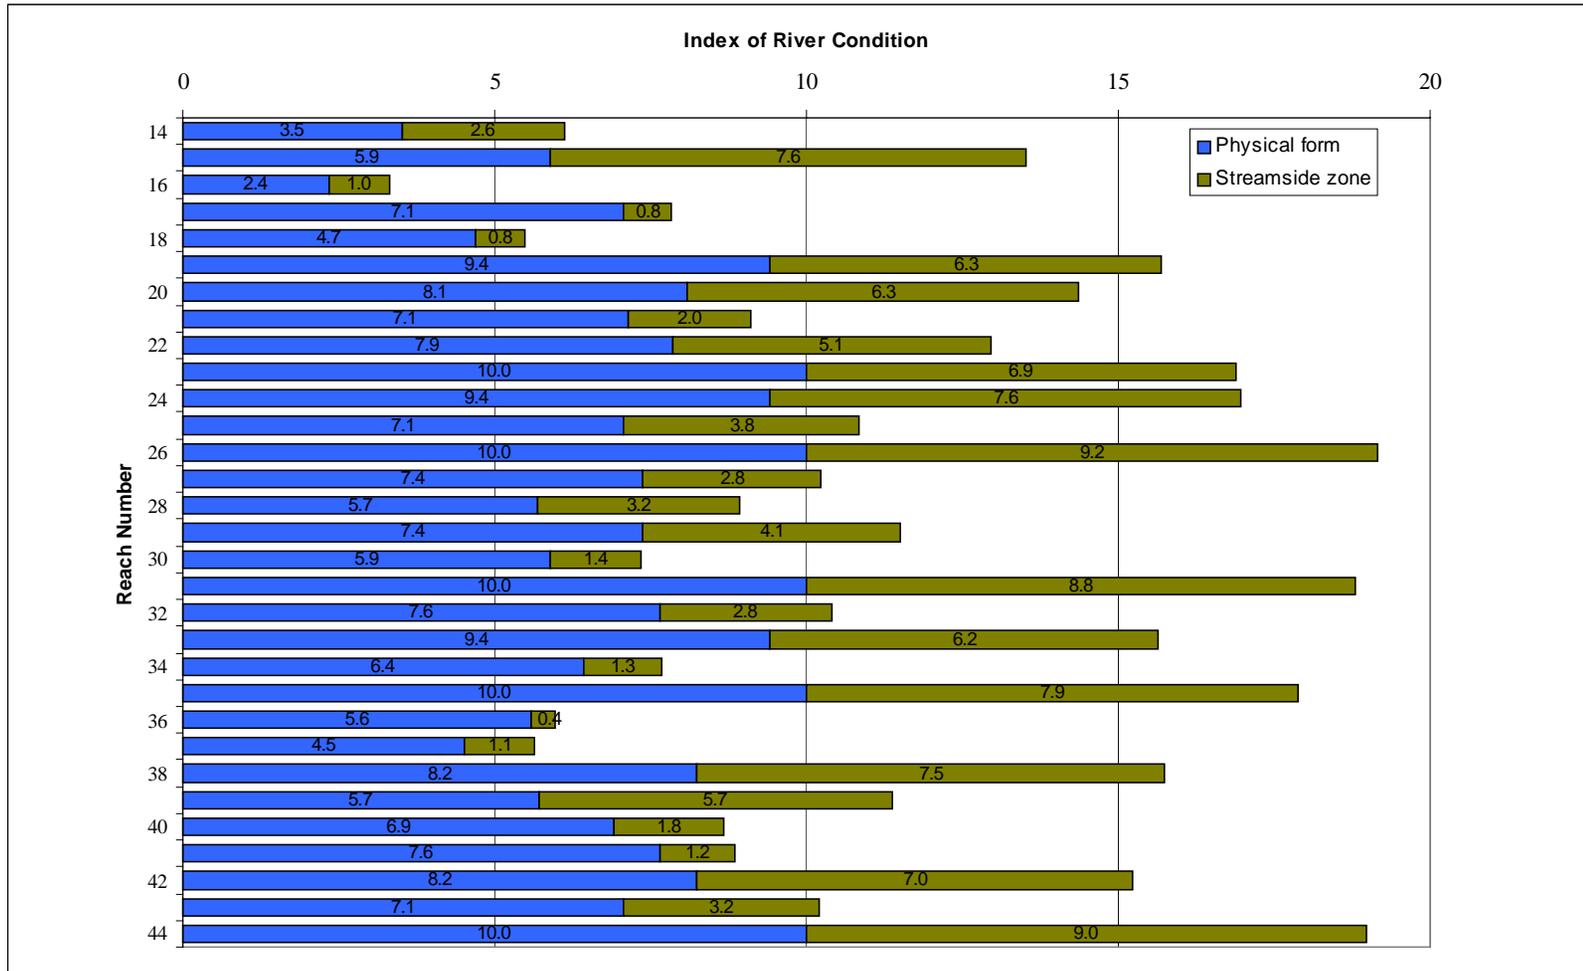
Figure 6. IRC results for the North Esk River tributaries.

Overall, the stream-side zone sub-index rated on average as in moderate condition for the tributaries, though individual site ratings varied from very poor to excellent. As with the physical form sub-index general trends were noted that related site condition to position within the sub-catchment and surrounding land usage.

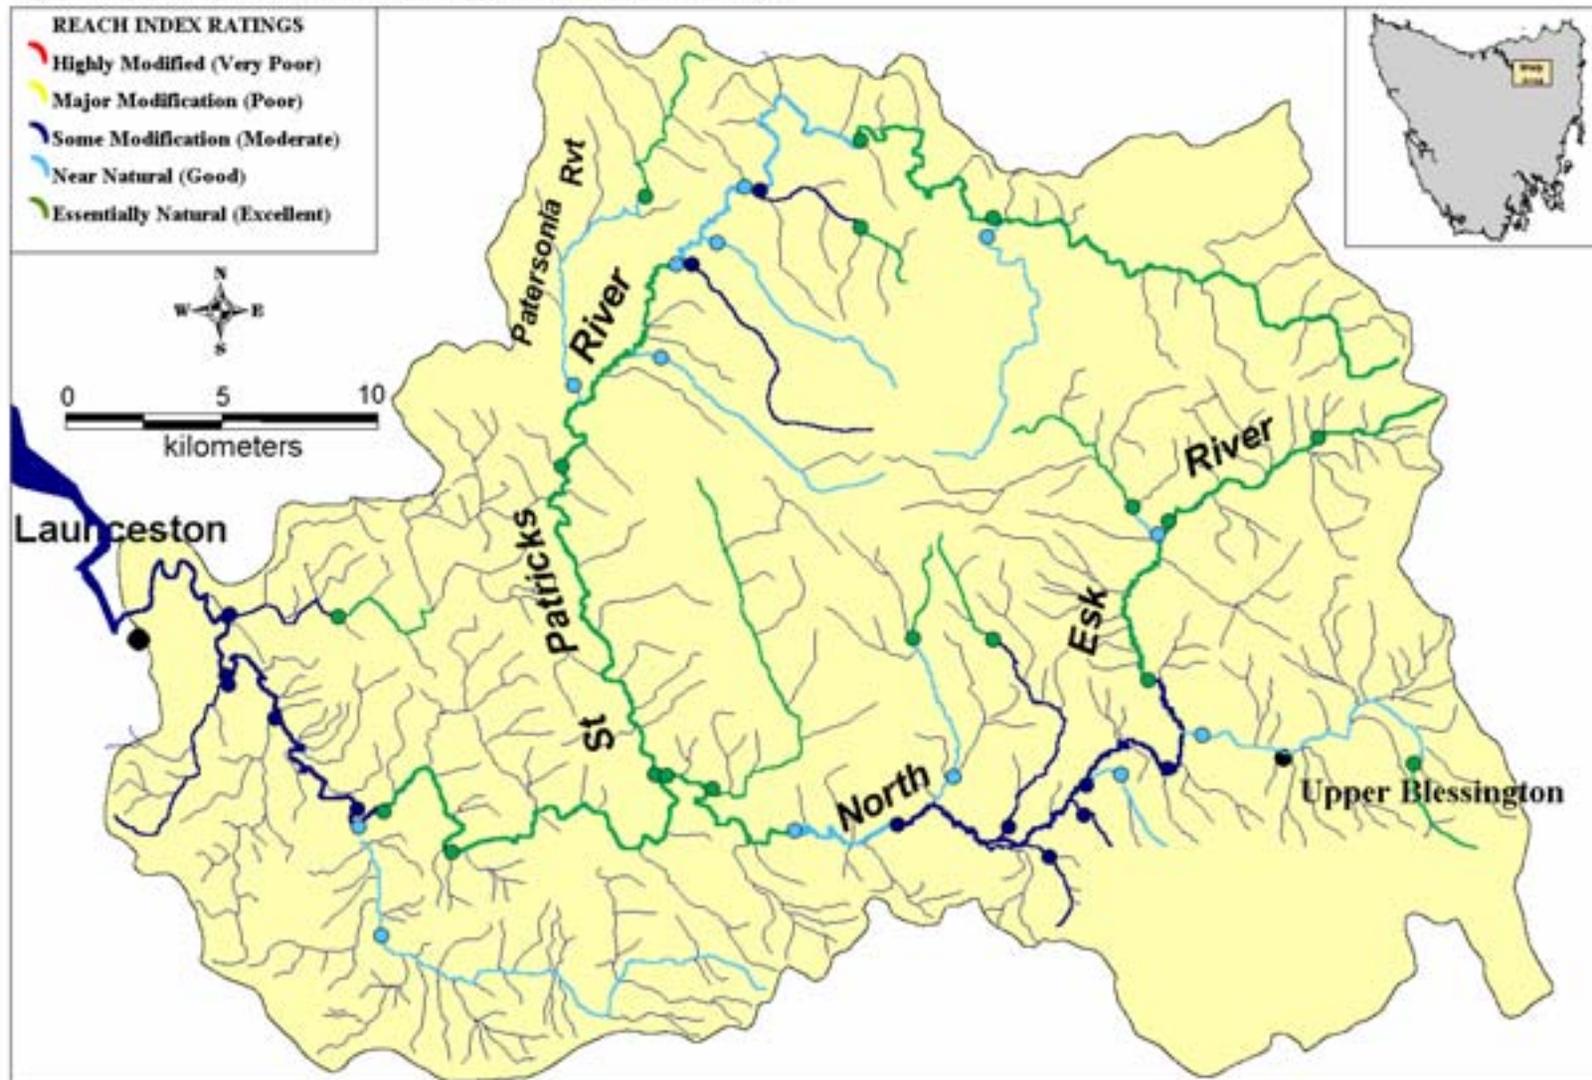
Figure 7. North Esk River Catchment, Physical form sub-index ratings.

Overall, the physical form sub-index rated as in good condition (near natural) for tributaries in the catchment. Where more than one site was surveyed on each tributary, a general trend of improved river condition at the upper reach of the tributary was noted. Distillery Creek improved from moderate condition at Site 14 (Distillery Creek upstream of the North Esk confluence) to excellent condition upstream of the filtration plant (Site 15). Seven Time Creek and Burns Creek were rated as in moderate condition at the lower sites (Sites 30 and 37, respectively) and in excellent condition at the upper sites (Sites 31 and 38, respectively). Patersonia Rivulet, Musselboro Creek, the Ford River, and Beckett Creek rated as in good condition at their lower sites (Sites 25, 34, 41, 43) and in excellent condition at the upper sites (Sites 26, 35, 42, 44).

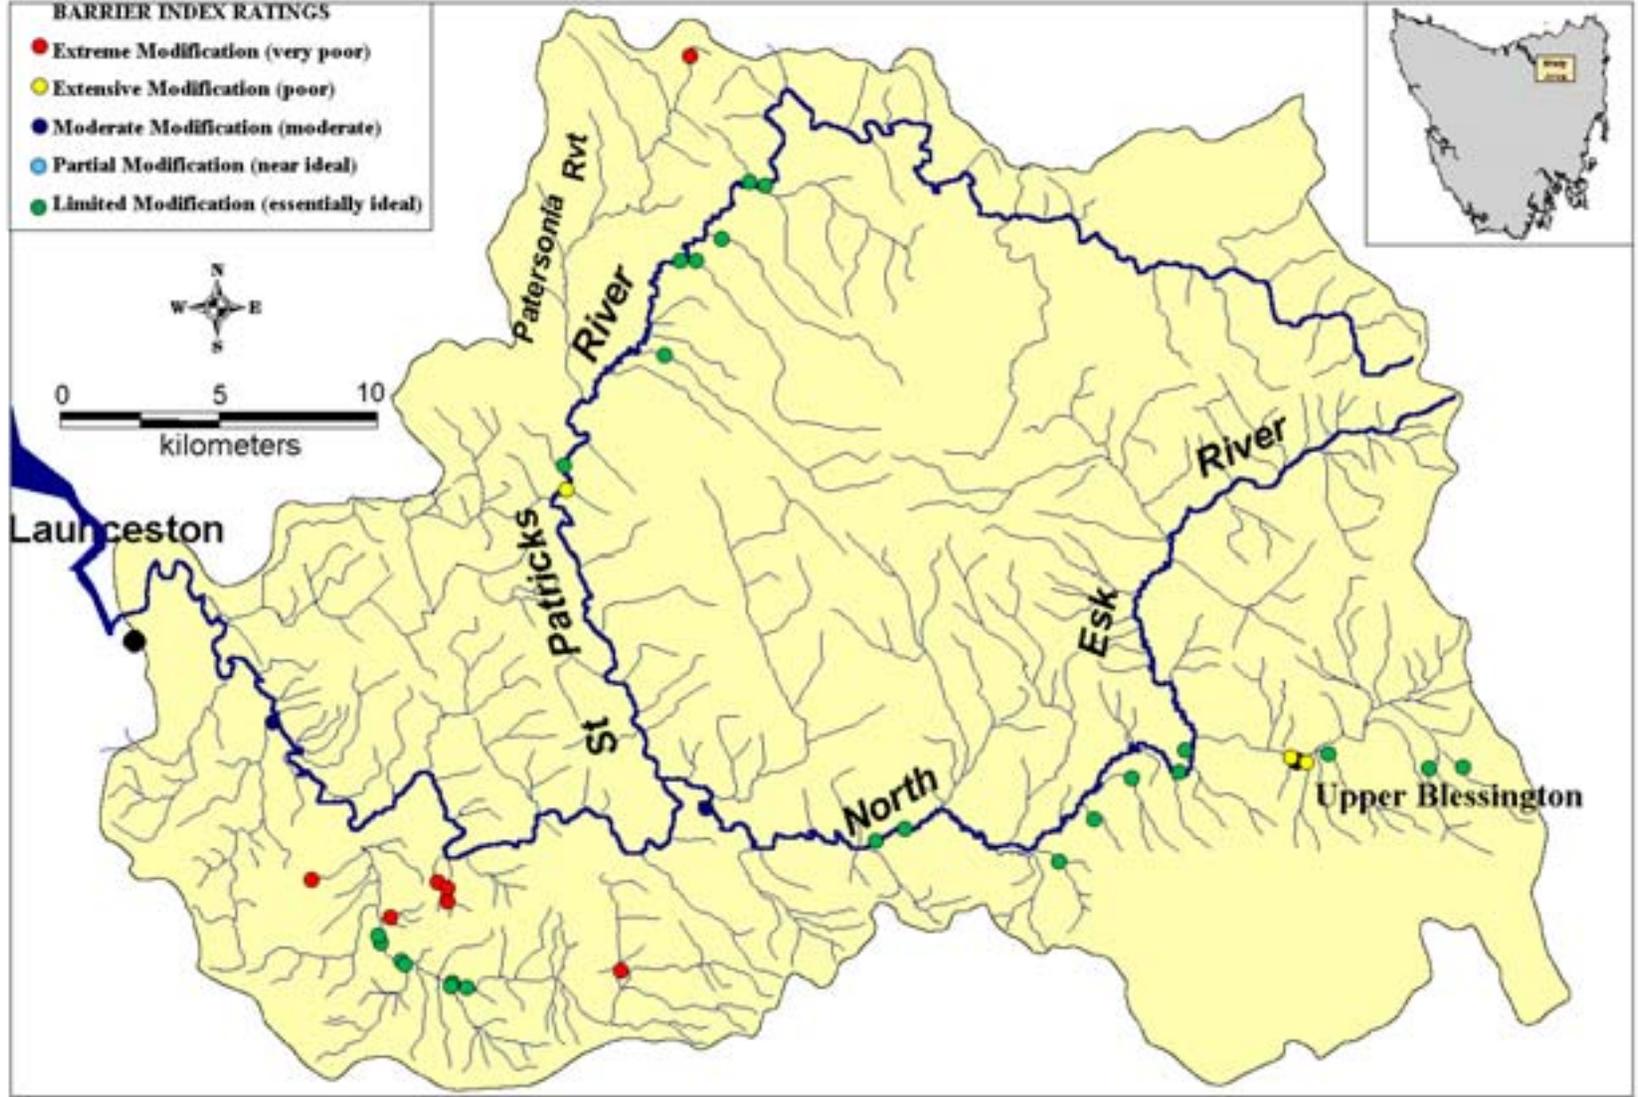
Figure 9. Hydrological connectivity for the North Esk catchment

Of the in-stream structures surveyed, 2 major weirs were identified to have the greatest effect on overall fish movement. The weir on the St. Patricks River at Nunamara was rated as a more complete barrier than the weir on the North Esk River at Clarks Ford Bridge. Clarks Ford Weir also scored a lower rating due to poor stream-side conditions and the weirs position within the lower catchment. The Chimney Saddle water supply weir rates as partially modified (although the rating bordered the “moderate” band). In the absence of the fish passage device the weir would have rated as of moderate effect upon condition.
