**Index of River Condition  
for the  
Ringarooma River Catchment**

Mark Nelson,  
Aquatic Ecologist  
Water Resource Assessment Branch  
DPIWE.

Report Series WRA 99/04  
March, 1999.

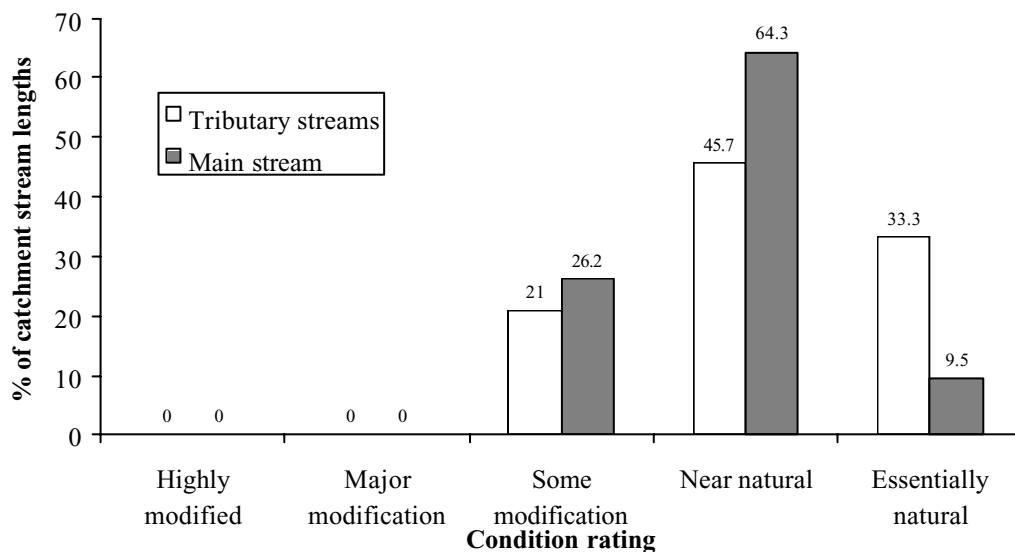
An examination of the overall condition ratings for both tributary and main-stream lengths reveals no section with a high or major modification to condition. Figure 1 details the rating structure of the proportion of stream lengths within the catchment. As illustrated in the chart over 50% of the catchment is in near or essentially natural condition, while approximately 20% of catchment streams indicate some modification from natural condition. The information available shows that overall condition of the catchment is respectably healthy.

**Figure 1. Proportional quantity of overall catchment river condition.**

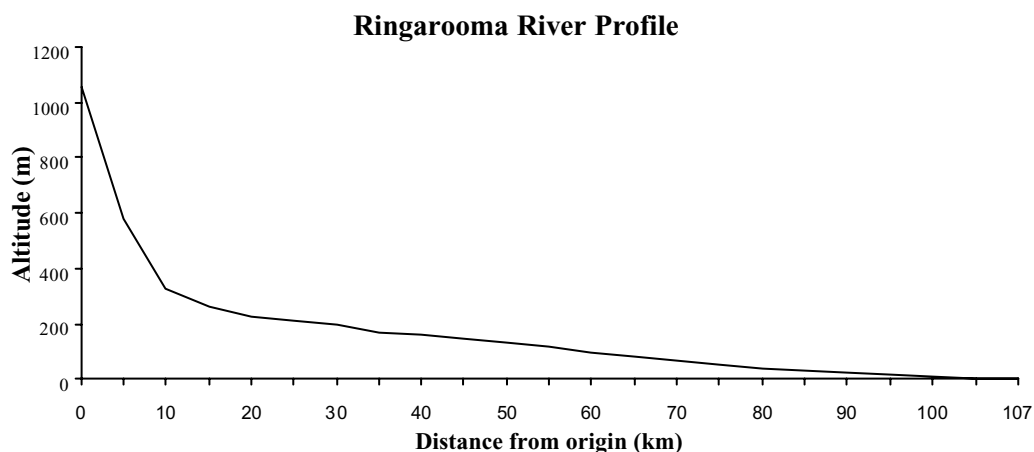
The study catchment was that containing the main Ringarooma River system. The catchment is situated in the north-east corner of the state. It is a class 6 river at its mouth. The river is 107 km long and originates at an altitude of 1000 m off Mt. Maurice (Figure 1). The main-stream is unregulated but there are some major storage's on several tributary streams. The river originates in a granodiorite massive and passes through largely granite in its middle reaches and into alluvium in its lower reaches.

Figure 1. Ringarooma R. altitudinal profile.

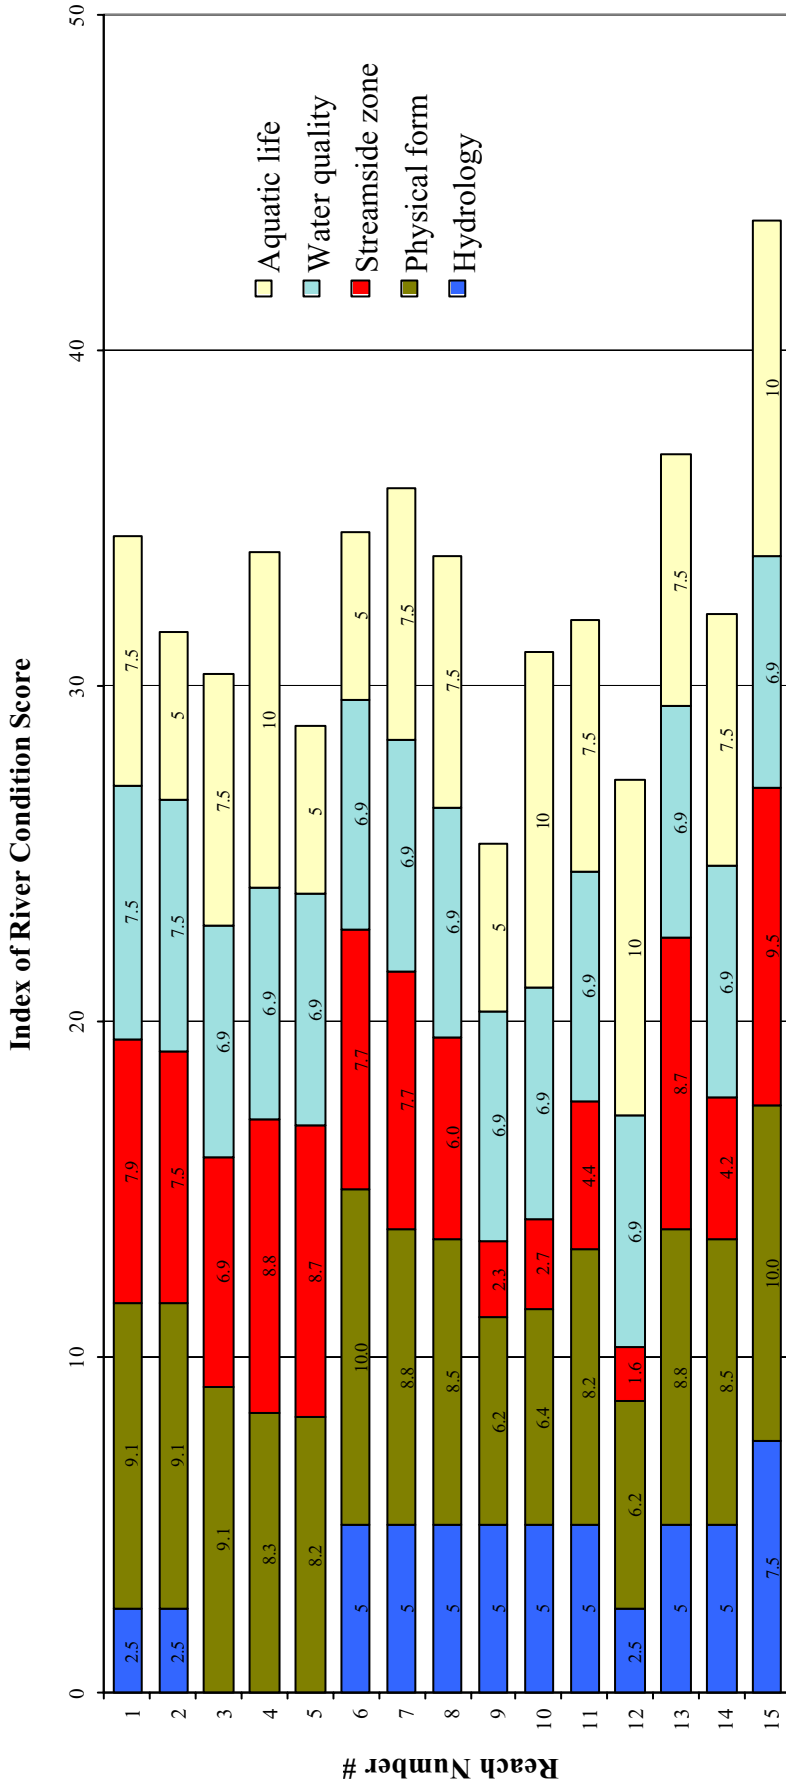
The IRC results for the main-stream Ringarooma River are provided in Figure 3. Parameters that suggest major or extreme modification from a natural or ideal condition are highlighted in Table 8 along with data gaps. 15 sites (reaches 1-15) were sampled in the main-stream.

- The IRC scores indicate the majority of sites fall within a state of near natural condition (IRC score 30 - 40). The uppermost site on the river was above all land use activities and clearly rated as in essentially natural condition. Only 3 sites came out as slightly modified (20 - 30, sites 5, 9 & 12).

- Physical form sub-index rated well for all sites which is a strong indicator of good habitat conditions.
- The streamside zone sub-index scores were the lowest of all the sub-index values with 5 sites rating below 5 points. Streamside cover revealed at least a major difference from ideal condition for 10 of the 15 sites. Structural intactness also revealed at least a major difference from ideal condition for 7 sites. This largely indicates inadequate riparian zones.

- Water quality at all sites was consistently high.
- IRC results suggests that aquatic life within the main-stream is in healthy condition with only 4 sites exhibiting average conditions and 3 sites with a maximum score of 10.

Figure 3. IRC results for the Ringarooma River main-stream sites.

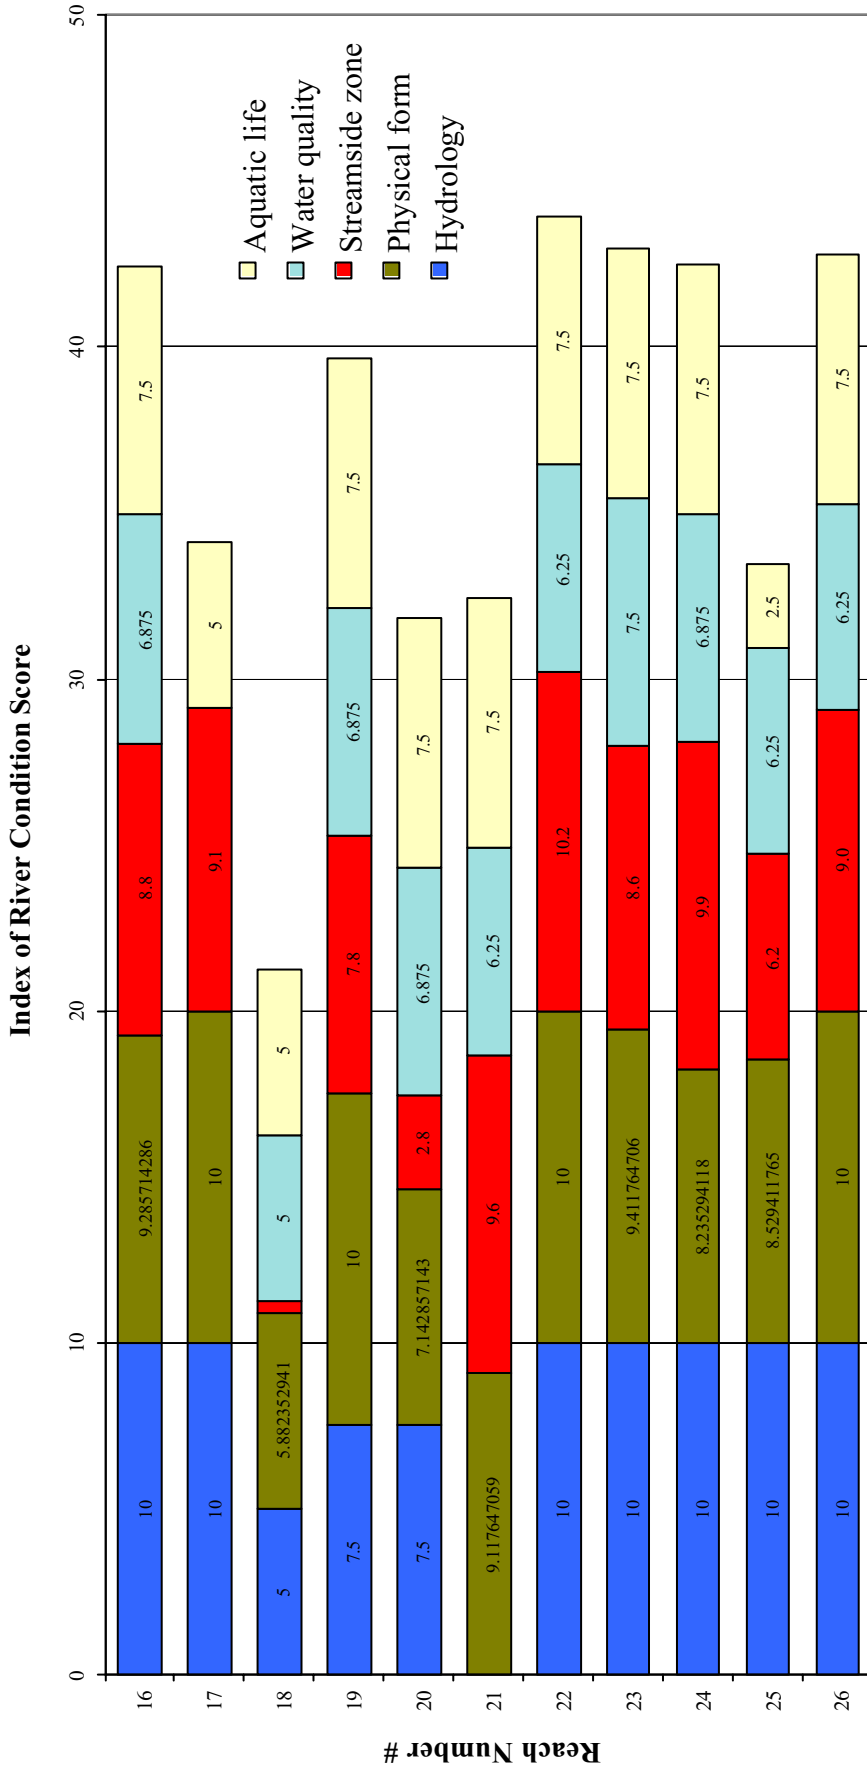
The IRC results for the tributary streams of the Ringarooma River are provided in Figure 4 and 5. Results are split purely to reduce complication in analysis due to the large number of sites. Parameters that suggest major or extreme modification from a natural or ideal condition are highlighted in Table 9 and 10 along with data gaps. A total of 13 tributaries consisting of 25 sites (reaches 16-26) were sampled.

- A general observation is the clear increase in overall scores between upper and lower sites in each tributary (reach 16 & 17, Wyniford R., reach 21 & 22, Frome R., reach 25 & 26 Cascade R.) Upper catchment sites are frequently less impacted than lower. Main Ck (reach 23 & 24) is essentially unimpacted for both sites. Site 18 (Davids Ck) is clearly the most impacted with moderate modification from natural conditions. The remaining tributary sites are all in good condition or higher.

- For all 11 reaches, the Physical form sub-index scored between 7.1 and 10, indicating an essentially natural condition except for Davids Ck (reach 18) which is highly modified from natural conditions.

- The Water quality sub-index showed no significant variation from a natural condition for all sites, except Davids Ck had a high turbidity reading indicating extreme modification. Data was missing for the upper Wyniford R. (reach 17) therefore limiting analysis of total IRC score for this site.

- The Aquatic life sub-index was extremely modified at the lower Cascade R. site (reach 25) possibly due to the effects of the upstream impoundment. Reach 17 and 18 (Wyniford R. and Davids Ck) showed some modification from natural condition.

Figure 4. IRC results for the Ringarooma River tributaries.

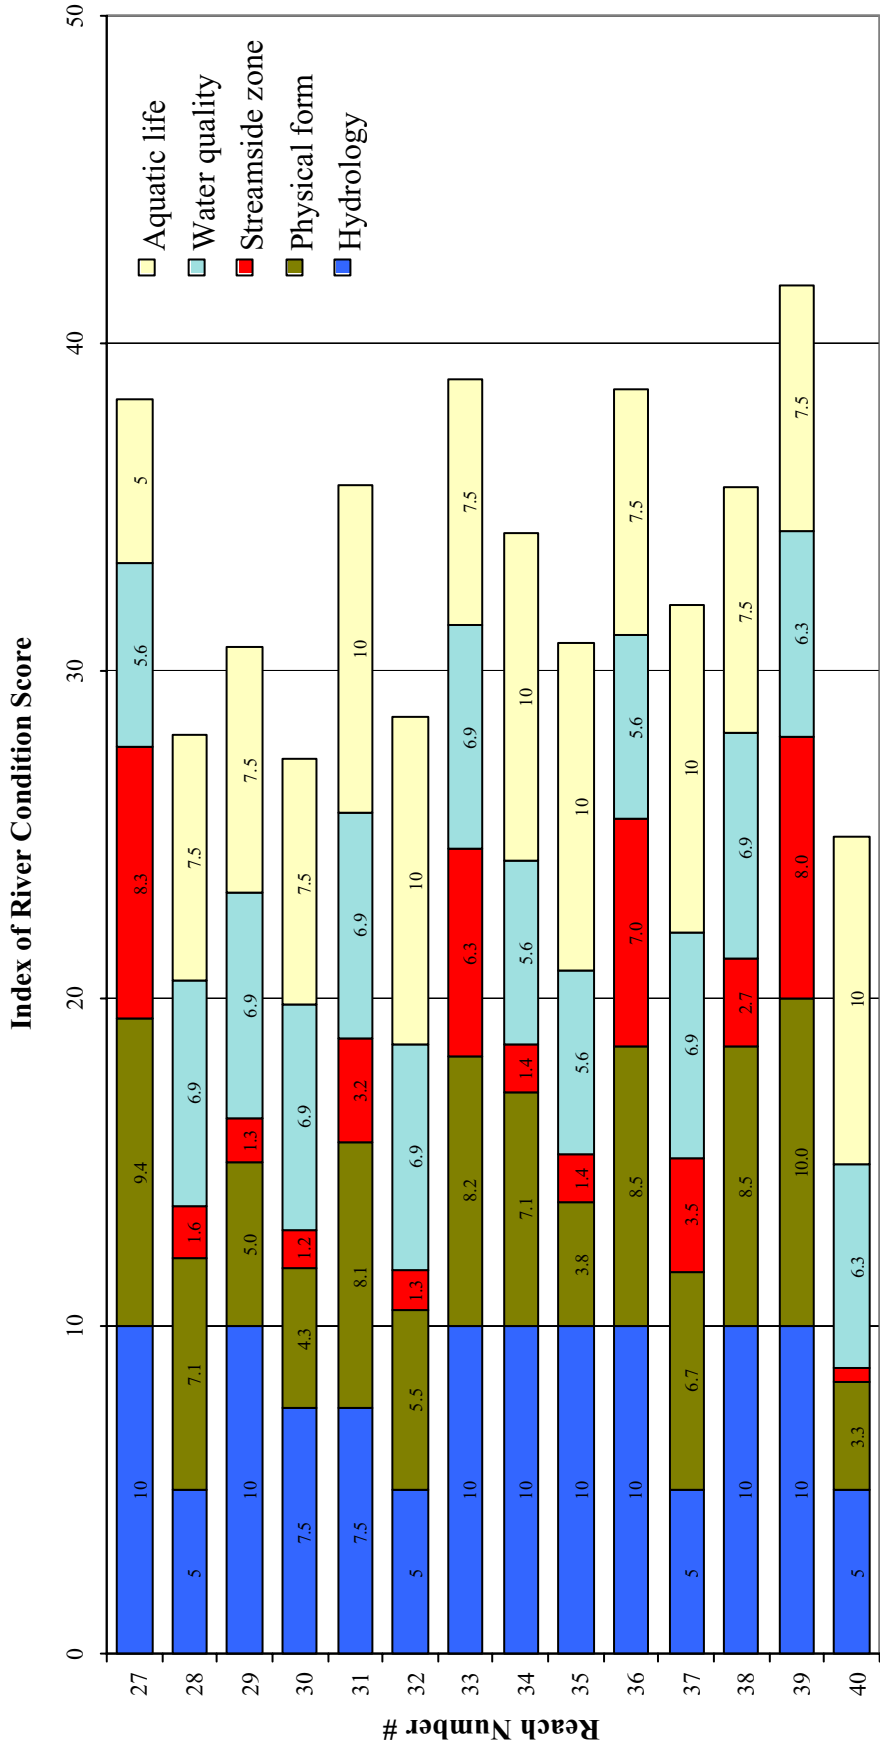
The second IRC results for the tributary streams of the Ringarooma River are provided in Figure 5 (reaches 27-40). Parameters that suggest major or extreme modification from a natural or ideal condition are highlighted in Table 10. No data gaps were encountered for this group of sites.

- Total IRC scores vary between moderate modification from a natural condition (4 reaches), near natural (9 reaches), to essentially natural (1 reach, upper Dunns Ck). Ledgerwood Ck is a highly modified agricultural catchment and there is little variation between the sites (reaches 28, 29 and 30). The Dorset R. (reaches 31, 32 and 33) and New R. (reaches 34, 35 and 36) also illustrate they are variable systems with the upper catchment sites (reach 33 and 36) scoring the highest. Dunns Ck (reach 39) is an unimpacted system and scores highly, whereas Federal Ck (reach 40) is a highly impacted reach and the low score illustrates this.

- The hydrology sub-index exhibits only minor modification from natural conditions for 6 reaches and the remaining 8 reaches rank as essentially natural.

- The Physical form sub-index varies considerably. Reach 35 (New R.) and 40 (Federal Ck) are highly modified with extreme modification in the parameters bank and bed stability, coarse woody debris and overall site disturbance. Reach 30 (upper Ledgerwood R.) exhibited extreme difference from natural or ideal conditions through the parameters bank stability, coarse woody debris and overall site disturbance. The parameter overall site disturbance exhibited extreme difference from natural or ideal conditions at 8 of 14 sites. This indicates that there are physical problems associated with many of the catchment tributary streams.

- Streamside zone sub-index showed extreme modification for 10 out of 14 reaches. Only reach 27 (Black Rivulet), 33 (upper Dorset R.), 36 (upper New R.) and 39 (Dunns Ck) exhibited minor modification. All the sub-index parameters were extremely modified in some form for all sites. Again this indicates that riparian condition of the catchment tributary streams is in poor condition, particularly for the upper catchment tributaries (Table 10).

- The Water quality sub-index parameters rated as moderate modification or near natural. pH exhibited extreme difference from natural or ideal conditions for reach 27 (Black Rt), 34, 35 and 36 (all New R. reaches).

Figure 5. IRC results for the Ringarooma River tributaries.

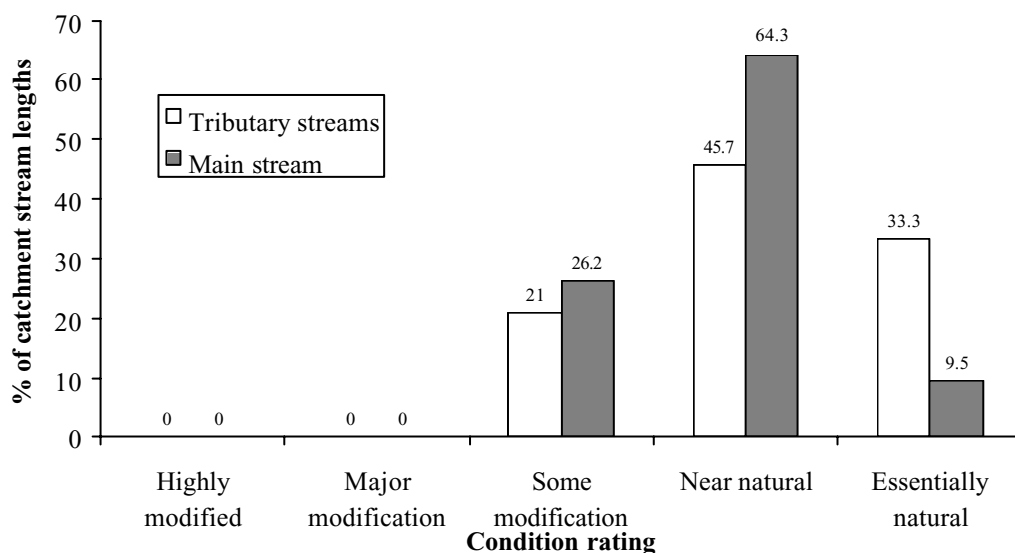
An examination of the overall condition ratings for both tributary and main-stream lengths reveals no section with a high or major modification to condition. Figure 6 details the rating structure of the proportion of stream lengths within the catchment. As illustrated in the chart over 50% of the catchment is in near or essentially natural condition, while approximately 20% of catchment streams indicate some modification from natural condition.

The information is limited by the location of each study site and stream length condition is an extrapolation of site information that were chosen as reasonably representative of that particular reach. Only major tributaries and the main-stream river were targeted. The information available shows that overall condition of the catchment is respectably healthy.

**Figure 6. Proportional quantity of overall catchment river condition.**

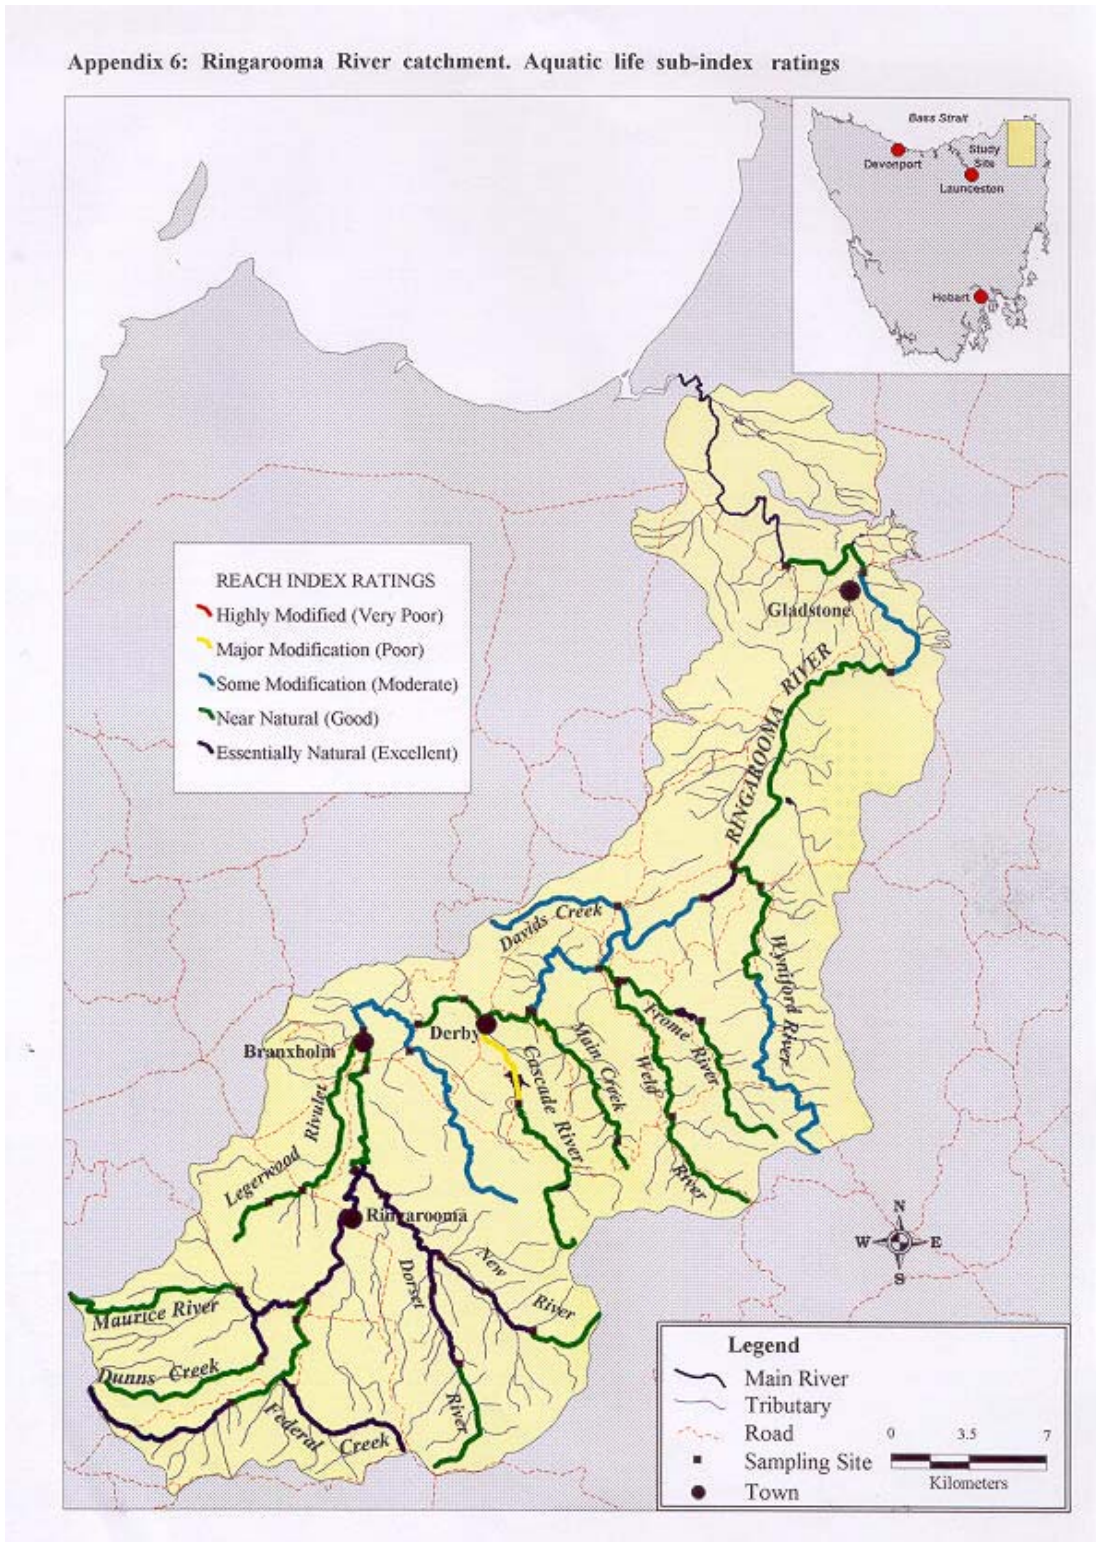
Appendix 6: Ringarooma River catchment. Aquatic life sub-index ratings
