Lower Gordon River erosion – history and lessons learned

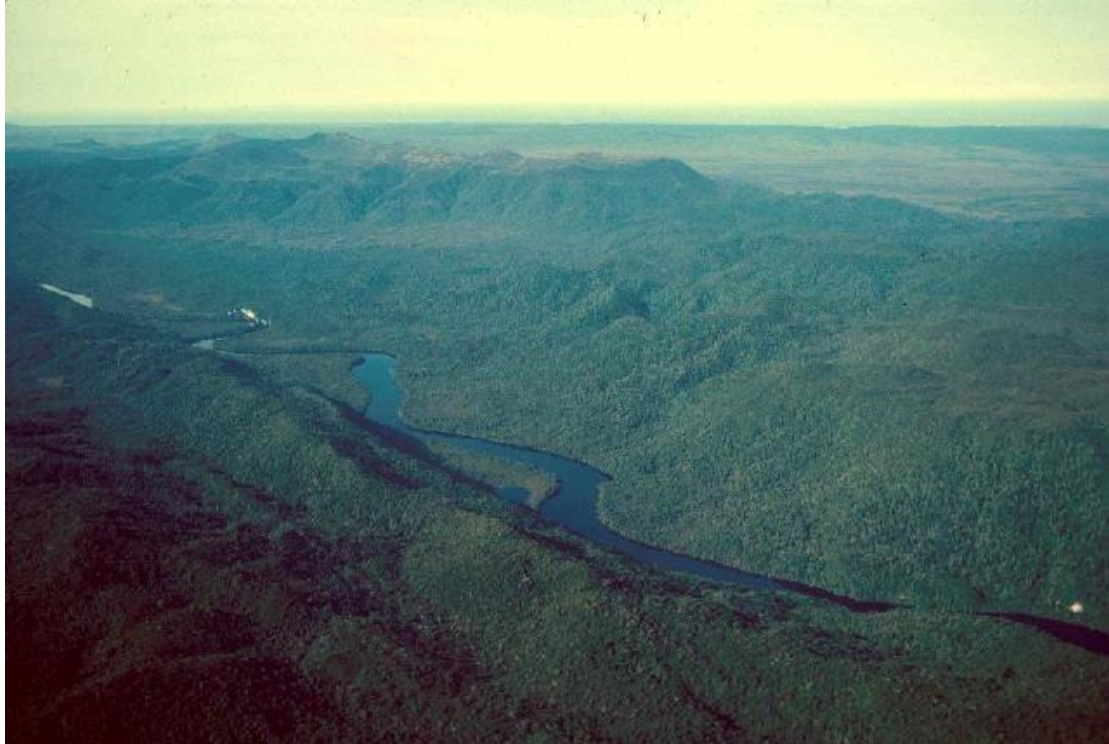
Aerial view of part of the deeply incised lower Gordon River, between Ghost Creek and Limekiln Reach.

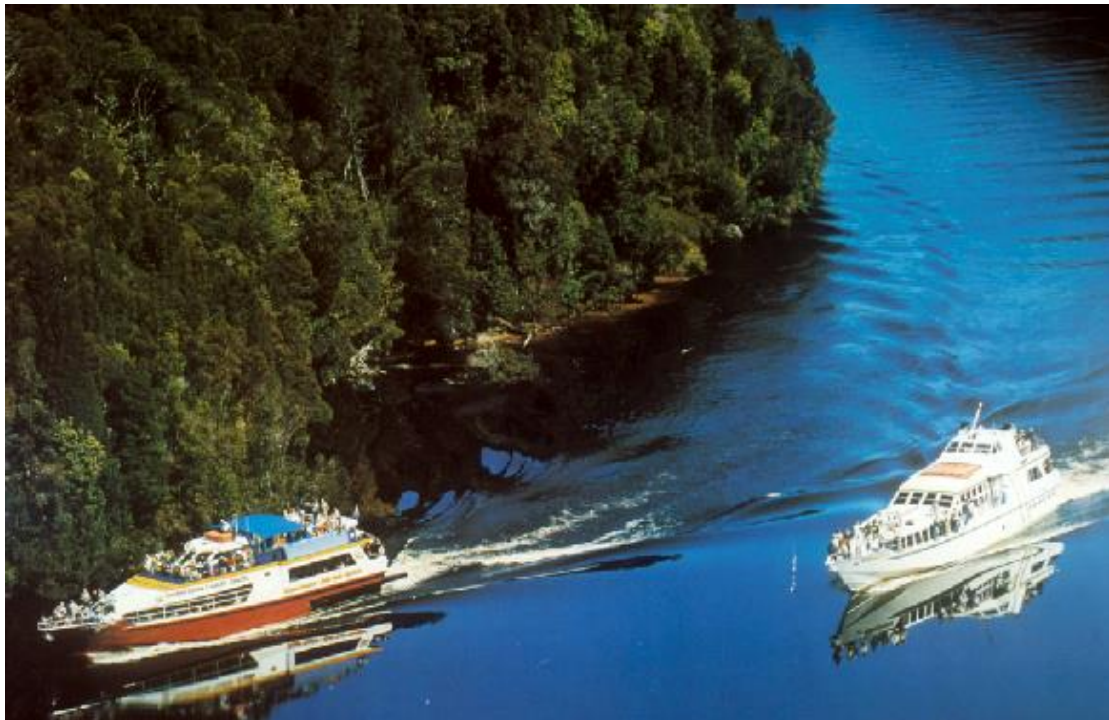
Even at their minimum possible speed these boats continued to cause erosion because the wake waves were larger than those of the natural wave climate.

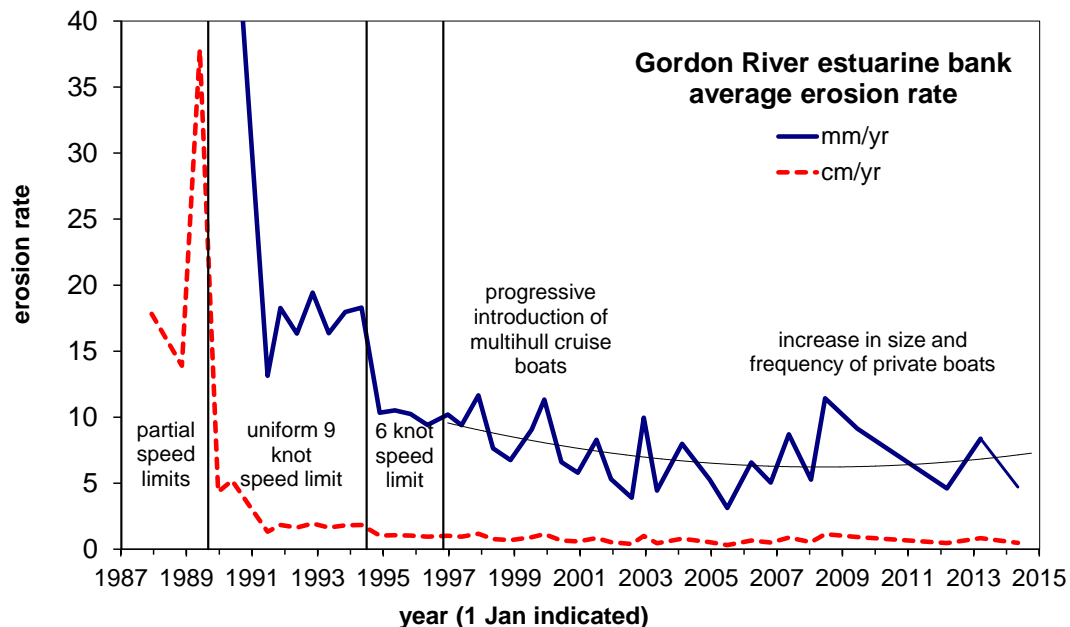
Change in the measured rate of muddy estuarine bank erosion in response to management controls introduced to limit erosion. The curve shows the best fit trend of the data since the first introduction of multihulled cruise vessels.

After a period of adjustment to the 1989 restrictions the rate of erosion had slowed to 1 – 2 cm per year. In 1992 and after much consultation a voluntary users code was produced to guide private visitors to the river in how to reduce damage caused by their vessels. However, people were beginning to question why PWS still regarded the erosion as a matter of concern and there were even pushes from some quarters to increase speed limits or re-open closed reaches. A series of radiocarbon dates obtained on bank sediments settled the matter in 1993. These proved that most banks had been stable for thousands of years, while those nearer the mouth had been very strongly depositional (Bradbury *et al.* 1995). On those banks it wasn't the absolute rate of erosion that mattered as much as the reversal of geomorphic process from deposition to erosion. Together with the data from ongoing monitoring, this supported implementation in 1994 of a further reduction in commercial vessel speed to six knots, as had been foreshadowed in 1989.
