**Index of River Condition
for the
Pipers River Catchment**

Mark Nelson,
Aquatic Ecologist
Land and Water Management Branch
Resource Management and Conservation Division
DPIWE.

Report Series WRA 99/22
December, 1999.

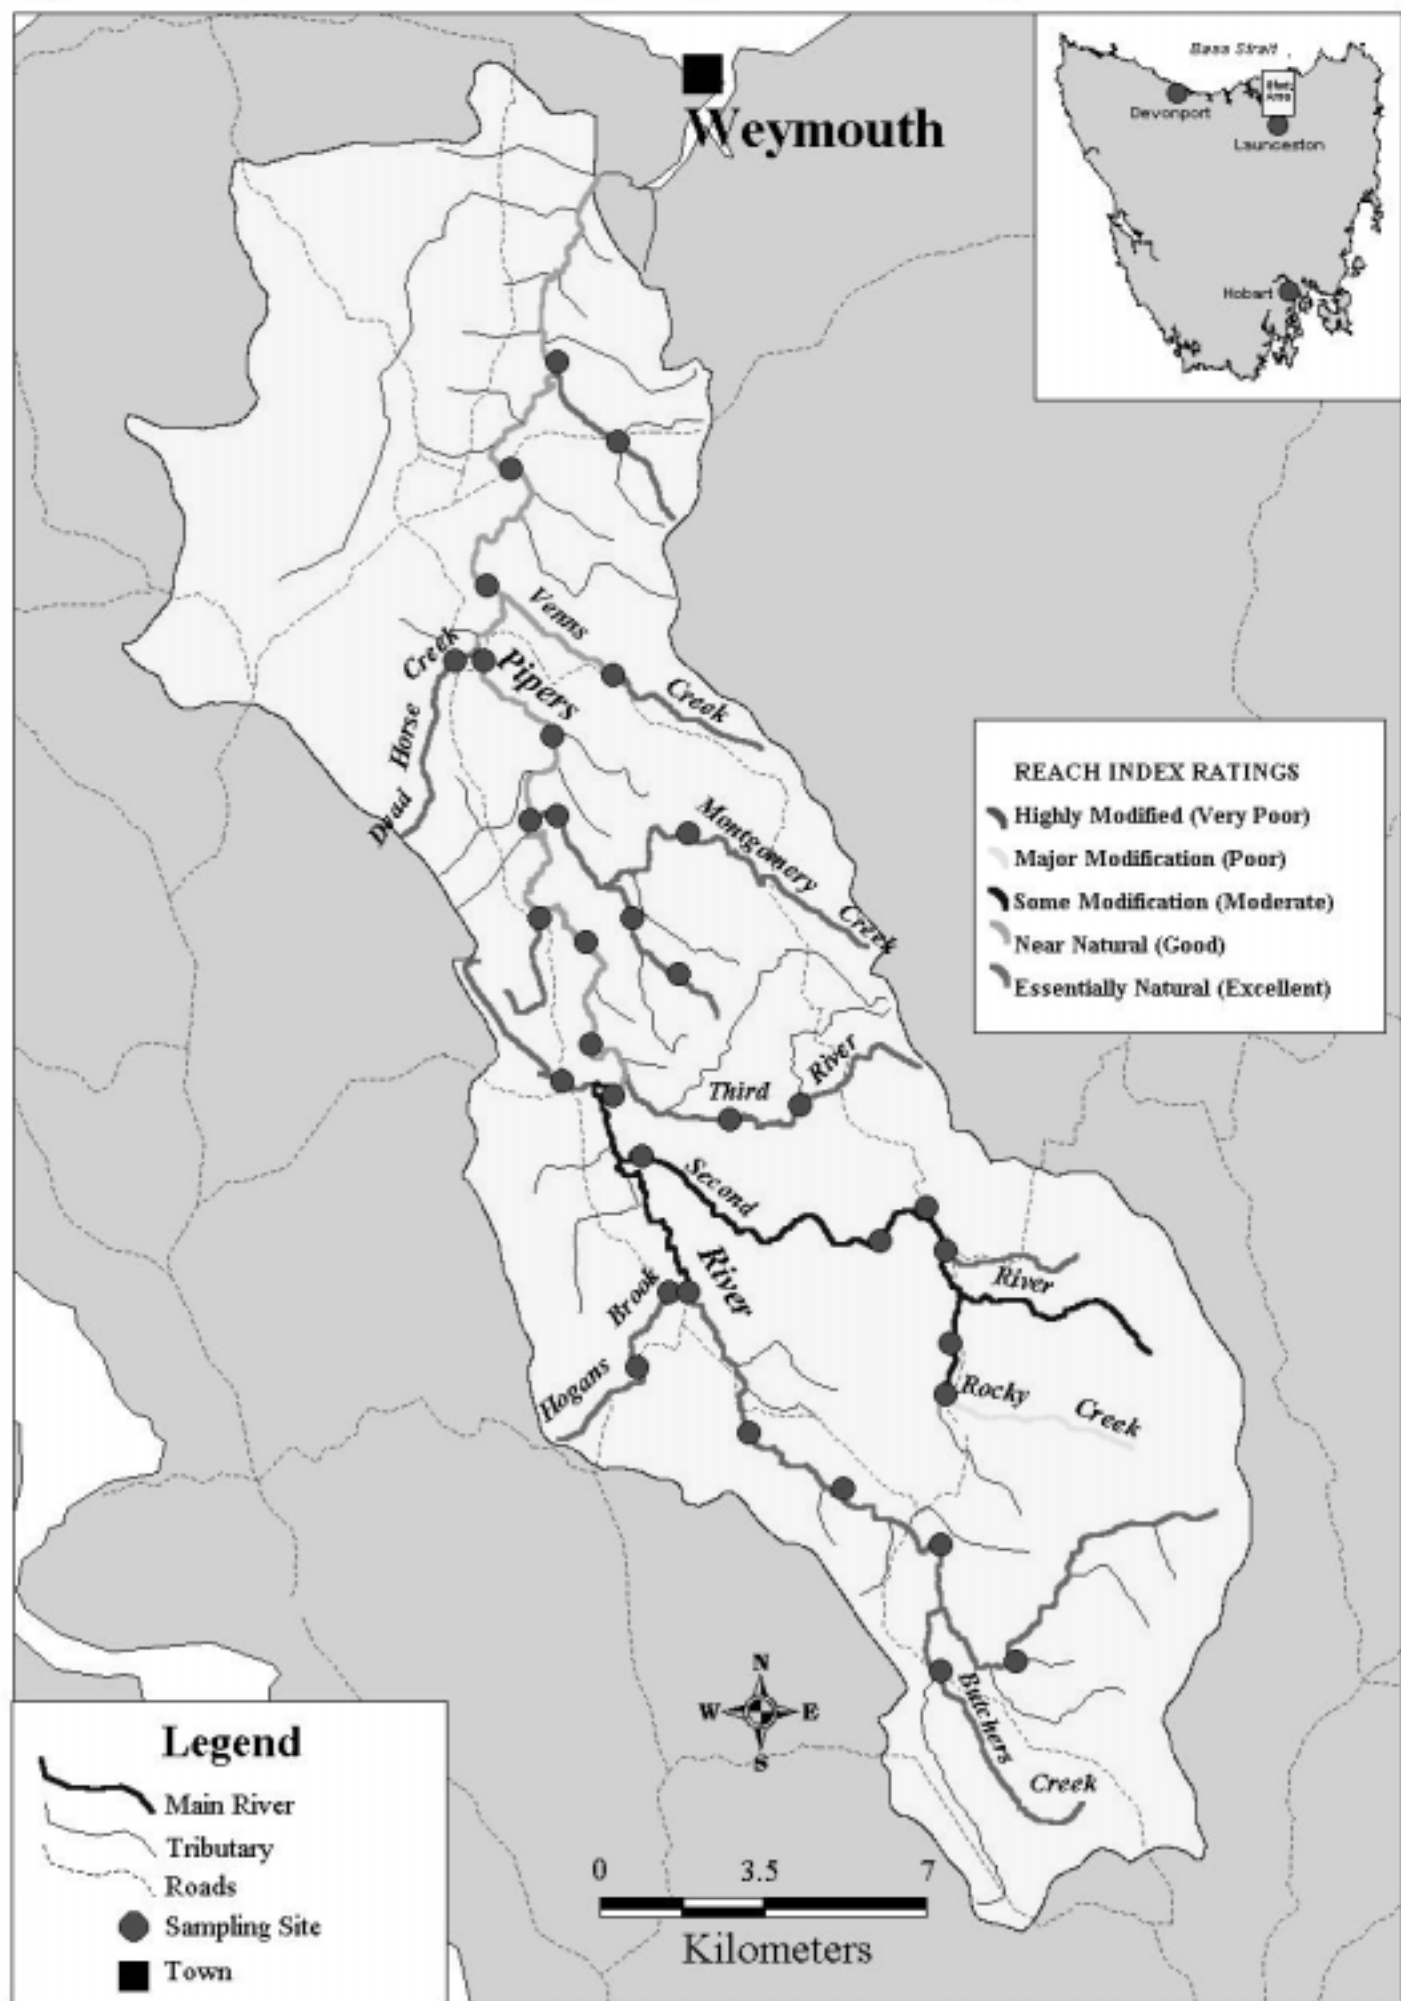
Appendix 7: Pipers River Catchment. Hydrological sub-index ratings

33	Weeds - blackberry, willow, thistle. No riparian zone. No indigenous plant regeneration. Unrestricted stock access to river banks.
34	Artificial damming of watercourse evident.
