Lower Gordon River erosion monitoring 2018

Update report for the period February 2018 to December 2018

March 2019
Jason Bradbury
Geoconservation Section
Natural Values Conservation Branch
Natural & Cultural Heritage Division
Department of Primary Industries, Parks, Water and Environment

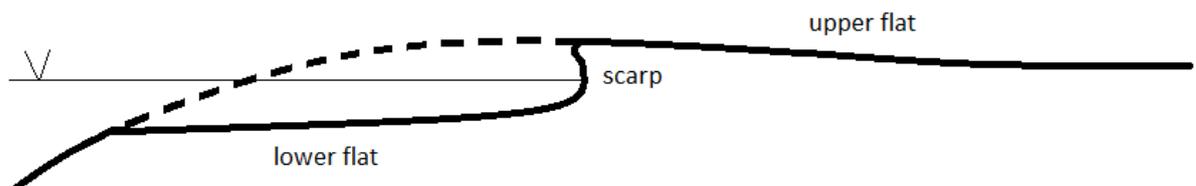
Figure 4: A generalised alluvial bank profile showing a near-vertical erosion scarp, typically 30 – 80 cm high, separating two sub-horizontal surfaces.

Since 1989, when commercial cruises were excluded from zone two, the rate of alluvial bank erosion in that zone has typically (but not always) been lower than that in zone one (Figure 5). That difference has been at times statistically significant and attributed to the effect of cruise boat wave wake. However for the past few years, the difference has been reversed and for the most recent monitoring period, was effectively negligible.

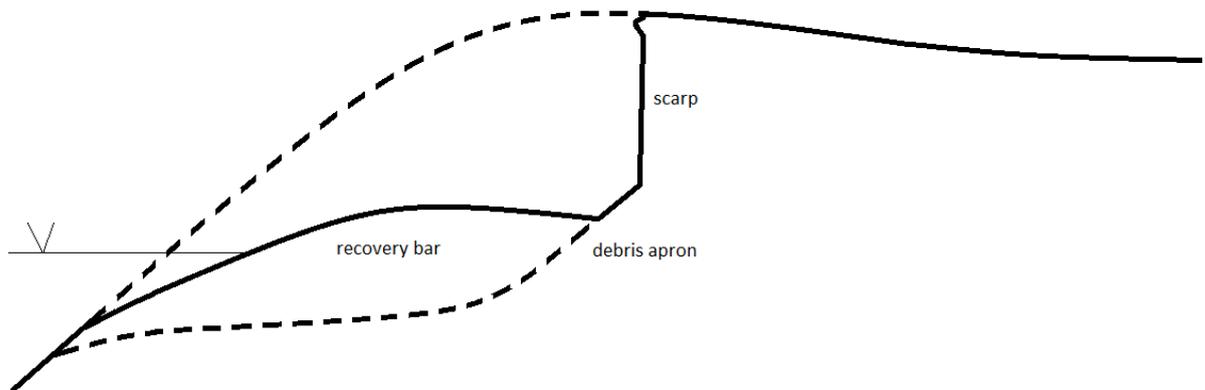
Figure 6: Generalised form of levee banks showing upper levee scarp, middle levee debris apron and lower levee recovery bar. The volume removed by erosion during the 1980s is shown between the dashed lines. The top of the scarp is typically 2 – 3.5 m above the normal water level shown.

Over the 2018 monitoring period only minor adjustments of the upper and middle levee landforms were recorded. The lower levees were considerably more active, with both deposition and erosion rates in excess of 100 mm/yr being recorded for an average of 6 mm/yr erosion. Note that the time-series plot (Figure 7) appears somewhat different to previous versions. That is because when levee bank erosion experiments were done in 2008-09 the experimental sites were excluded from results because of the artificially higher rate of erosion caused by numerous experimental boat passes during the relevant monitoring period. However they were also erroneously excluded from 2012 and 2013 data sets. That error has now been corrected.
