RIVER DERWENT FLOOD DATA BOOK

River Derwent Flood Data Book

Report Series WRA 00/01
May 2000.

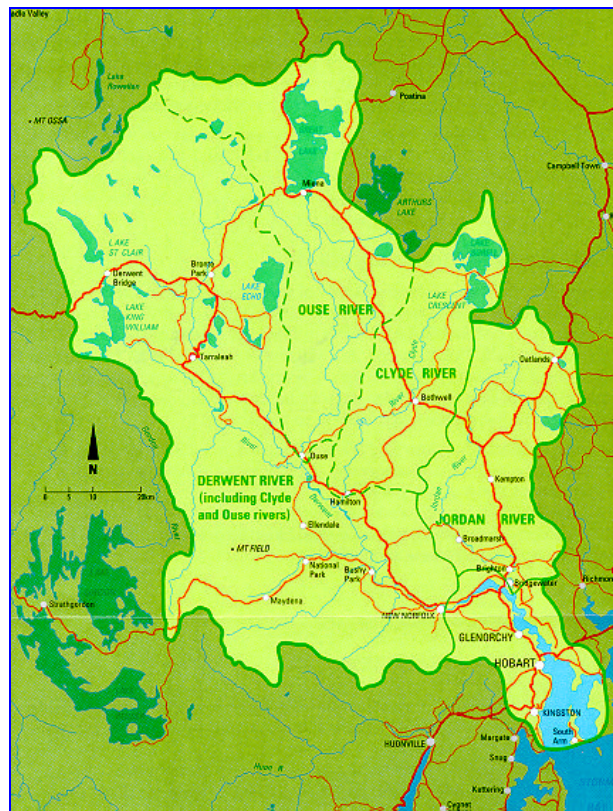
Figure 1: The Derwent Catchment (Coughanowr, 1995).

The River Derwent flows through mountainous country from the central highlands to the ocean. The catchment is approximately 10,200km², refer Figure 1. In the upper reaches, the Florentine, Ouse, Tyenna, Styx, Plenty and Clyde Rivers largely supply stream flow to the River Derwent. This river is interrupted by seven major dams and hydro-electric regulation from its headwaters at Cradle Mountain to its discharge into the Derwent Estuary.

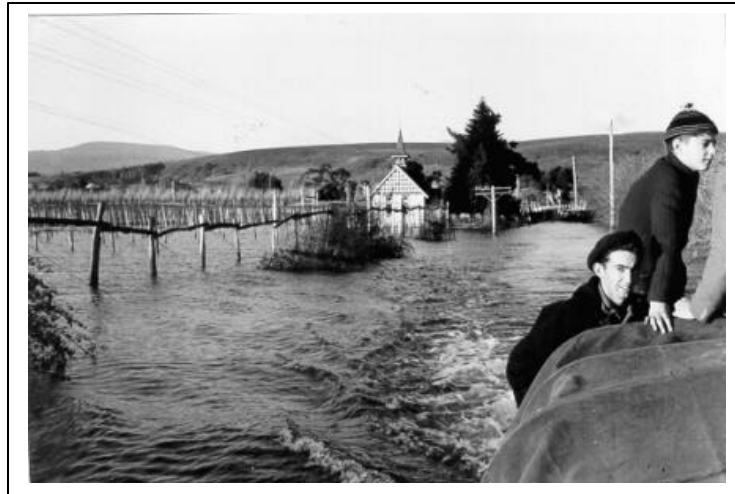
Plate 4: May 1958 – Flooding between the Styx River and River Derwent at Bushy Park, looking towards the Derwent Church of England with the *Kentdale Estate* hop fields to the left. Floodwaters rose to the top of the Church's sandstone foundations.

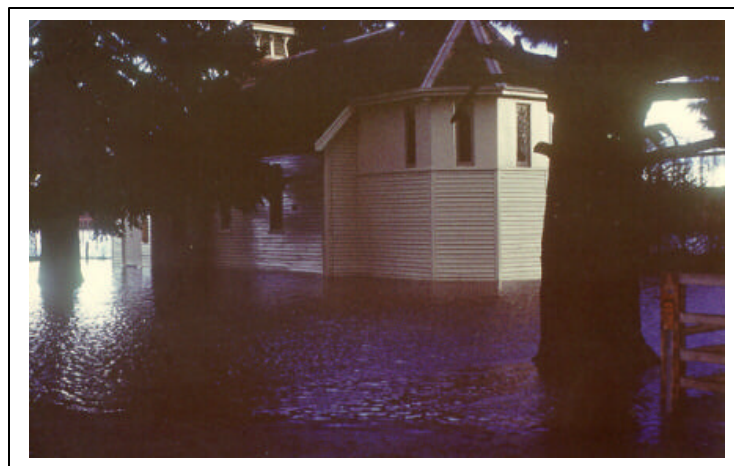
Plate 5: November 1974 – Flooding at the Derwent Church of England at Bushy Park. Floodwaters rose to the base of the doorstep and the top of the sandstone foundations.

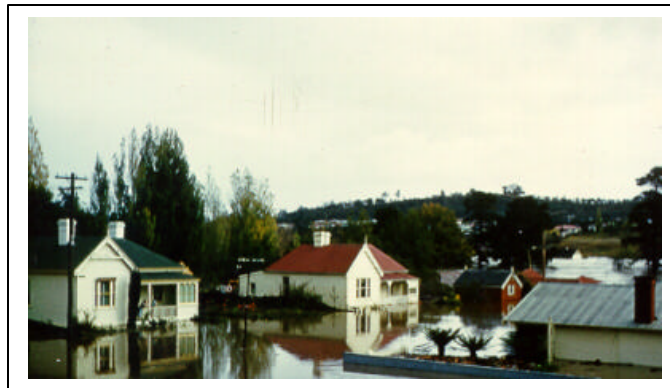
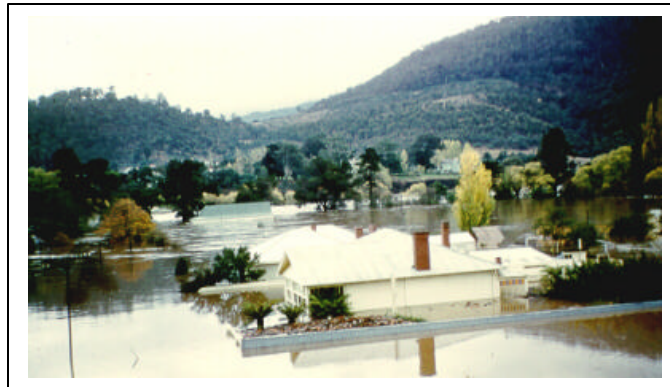
Plates 6 and 7: April 1960 – Flooding was extensive at New Norfolk. The corner of Ferry Street and Montagu Street is pictured with No 2 and No 4 Ferry Street above, and the New Norfolk Esplanade and No 1 Ferry Street below.

A peak discharge of over 3,100 cumecs was recorded at Macquarie Plains (Hydro-Electric Commission, 1992). This equates to approximately a 1:150 AEP flood event. Large flows in the River Derwent were due to combined floodwaters from the Ouse and Clyde Rivers and at Macquarie Plains, water rose to 10.2 metres (2.0 metres higher than flooding in 1952). Downstream at New Norfolk, the river was considered 3.0 metres higher than in 1952 and water rose 1.0 metre above the Lyell Highway Bridge to cut off the township. At the junction of Church Street and the Lyell Highway at New Norfolk, the tips of the guideposts could be seen above *the swirling waters* of the Lachlan River (*The Mercury*, 1960). The New Norfolk Esplanade was well under water and floodwaters rose 1.2 metres over the road at Sorell Creek.

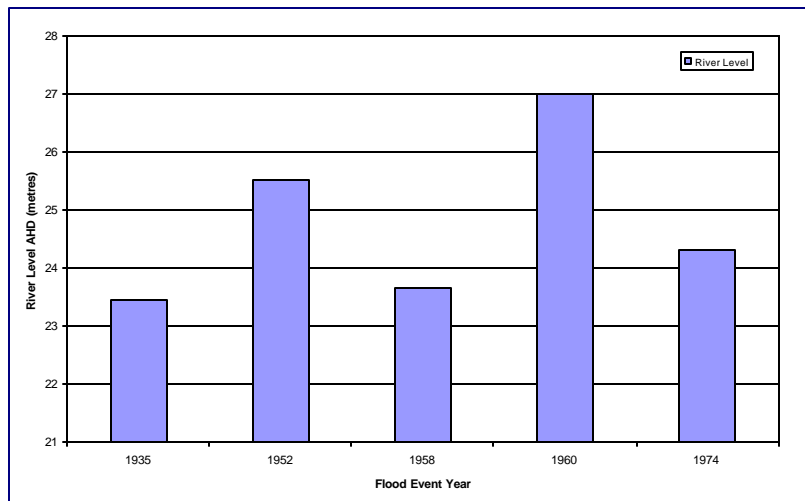
Graph 2: River levels recorded at Bushy Park from the Derwent Church of England (Saint Augustins Church) area.

The following graph (Graph 2) provides a visual representation of the river level (AHD) at Bushy Park for the major flood events between the period 1935 to 1974. This graph visually indicates the sheer magnitude of the 1960 event when compared to other floods.
